| <b>Bamble kirke</b> | <b>Skadeomfang vegger</b> |
| Akasia , AEF | Borremotstandsmålinger |
| 19.09.2019 | R. Klumpp, Ø. Mortensen |

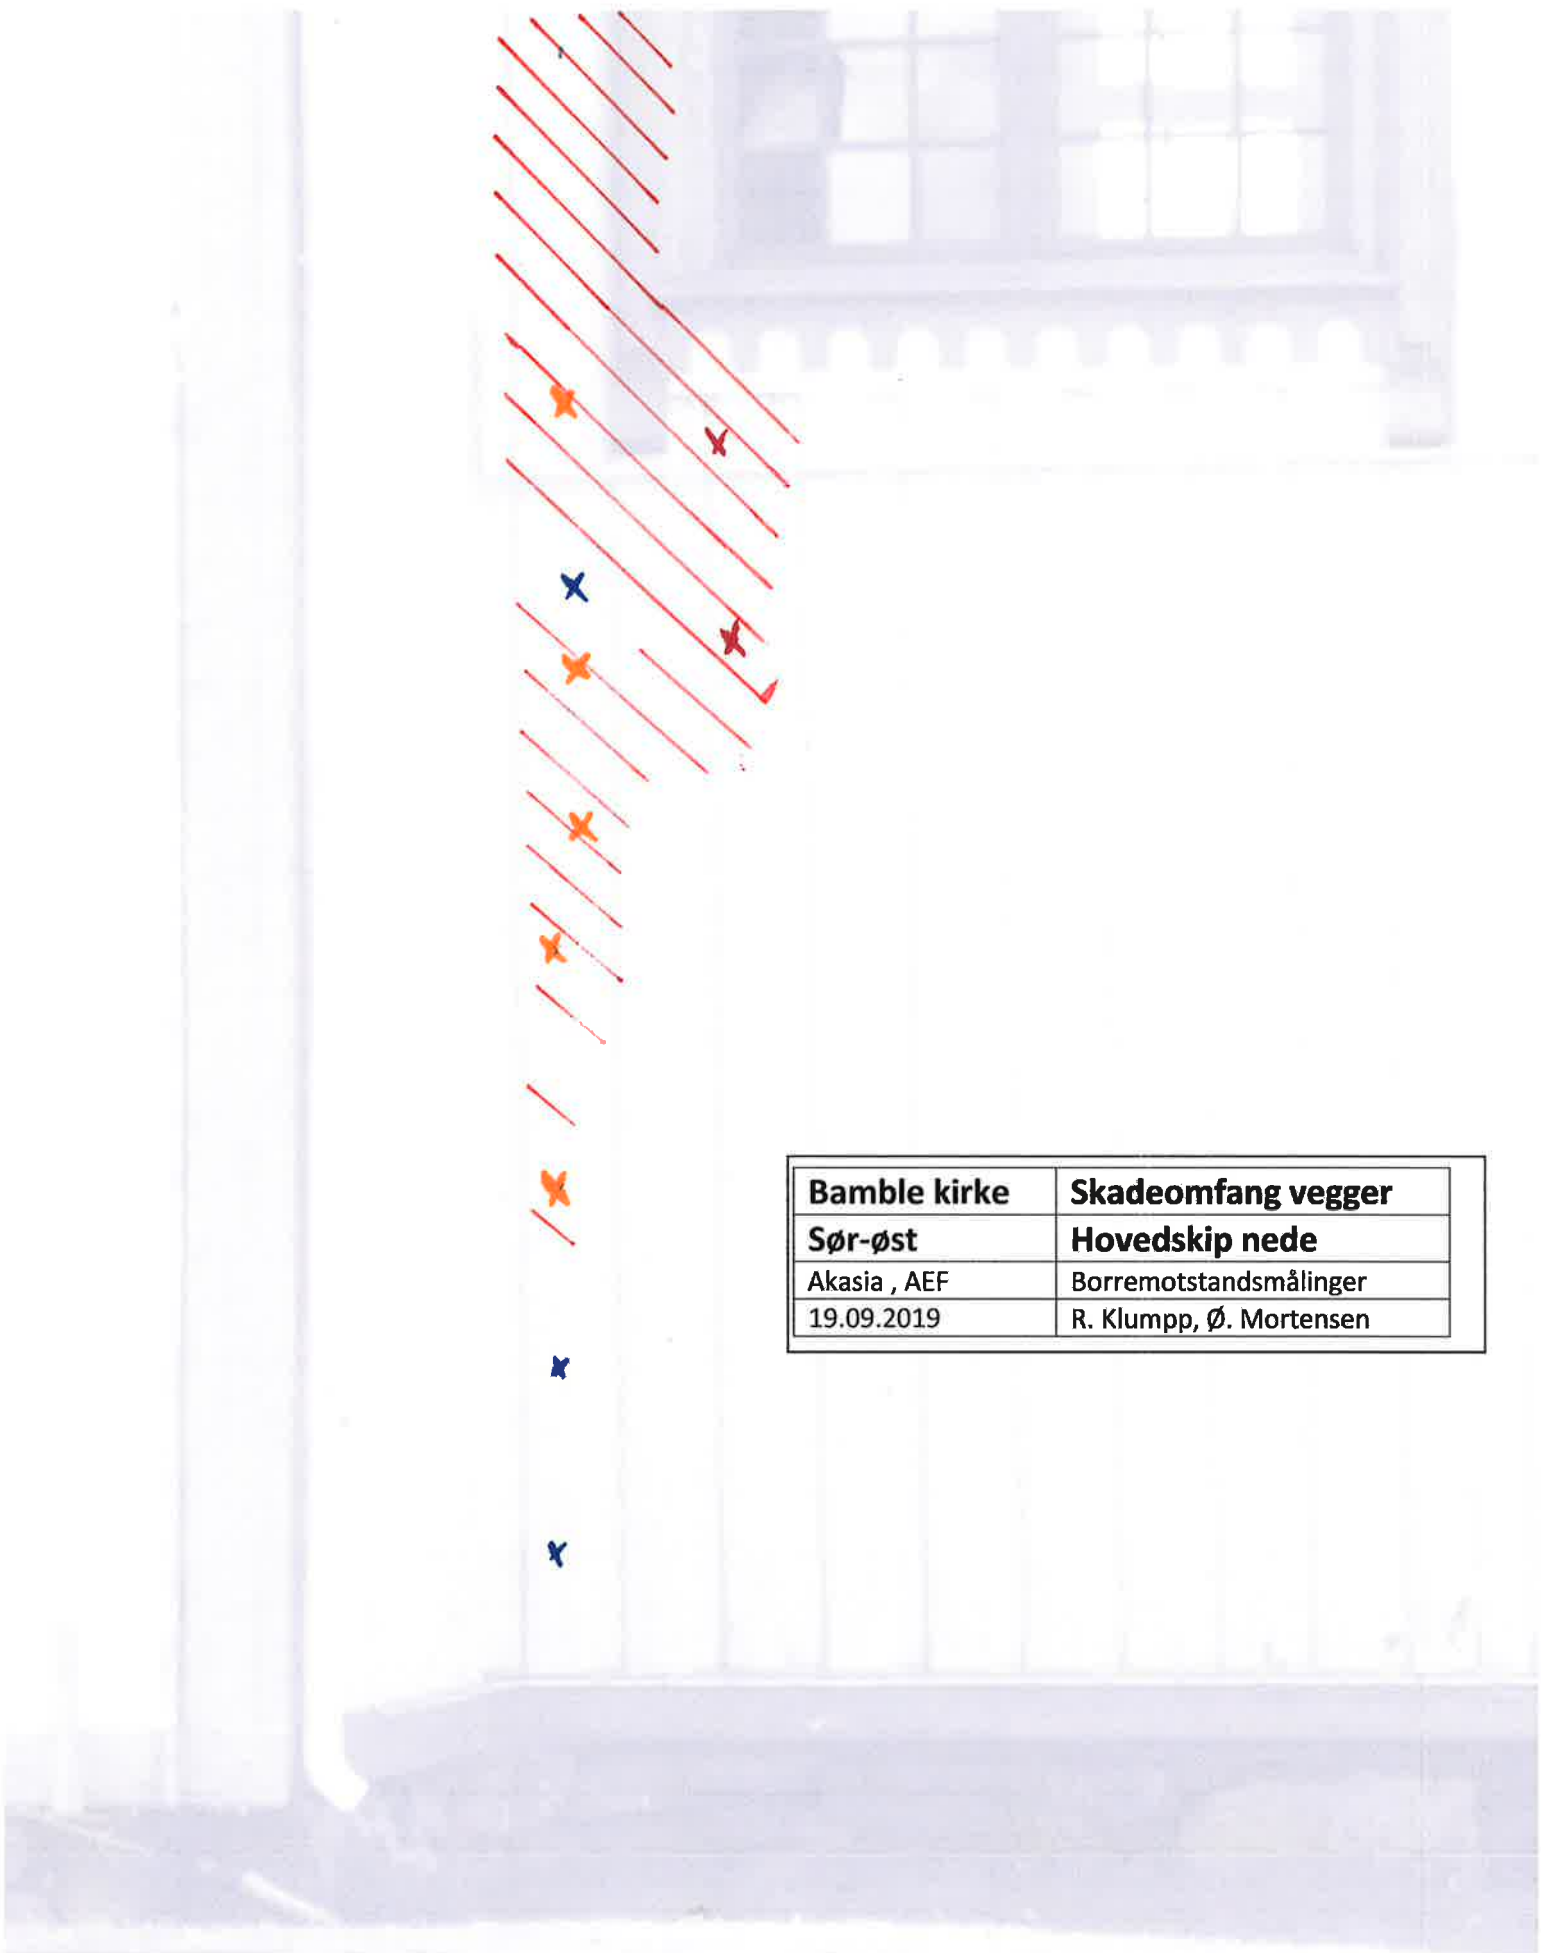
| <b>Sør-øst</b> | <b>Hovedskip nede</b> |

| <b>Bamble kirke</b> | <b>Skadeomfang vegger</b> |
| Akasia , AEF | Borremotstandsmålinger |

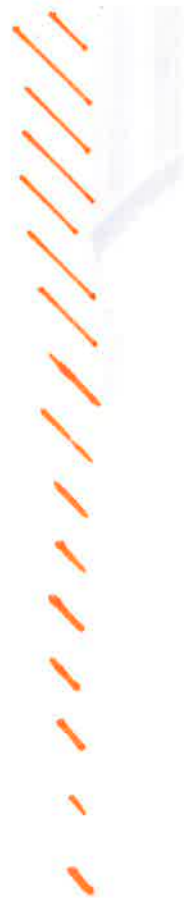
| <b>Sør-øst</b> | <b>Sideskip nede</b> |

| <b>Bamble kirke</b> | <b>Skadeomfang vegger</b> |
| Akasia , AEF | Borremotstandsmålinger |

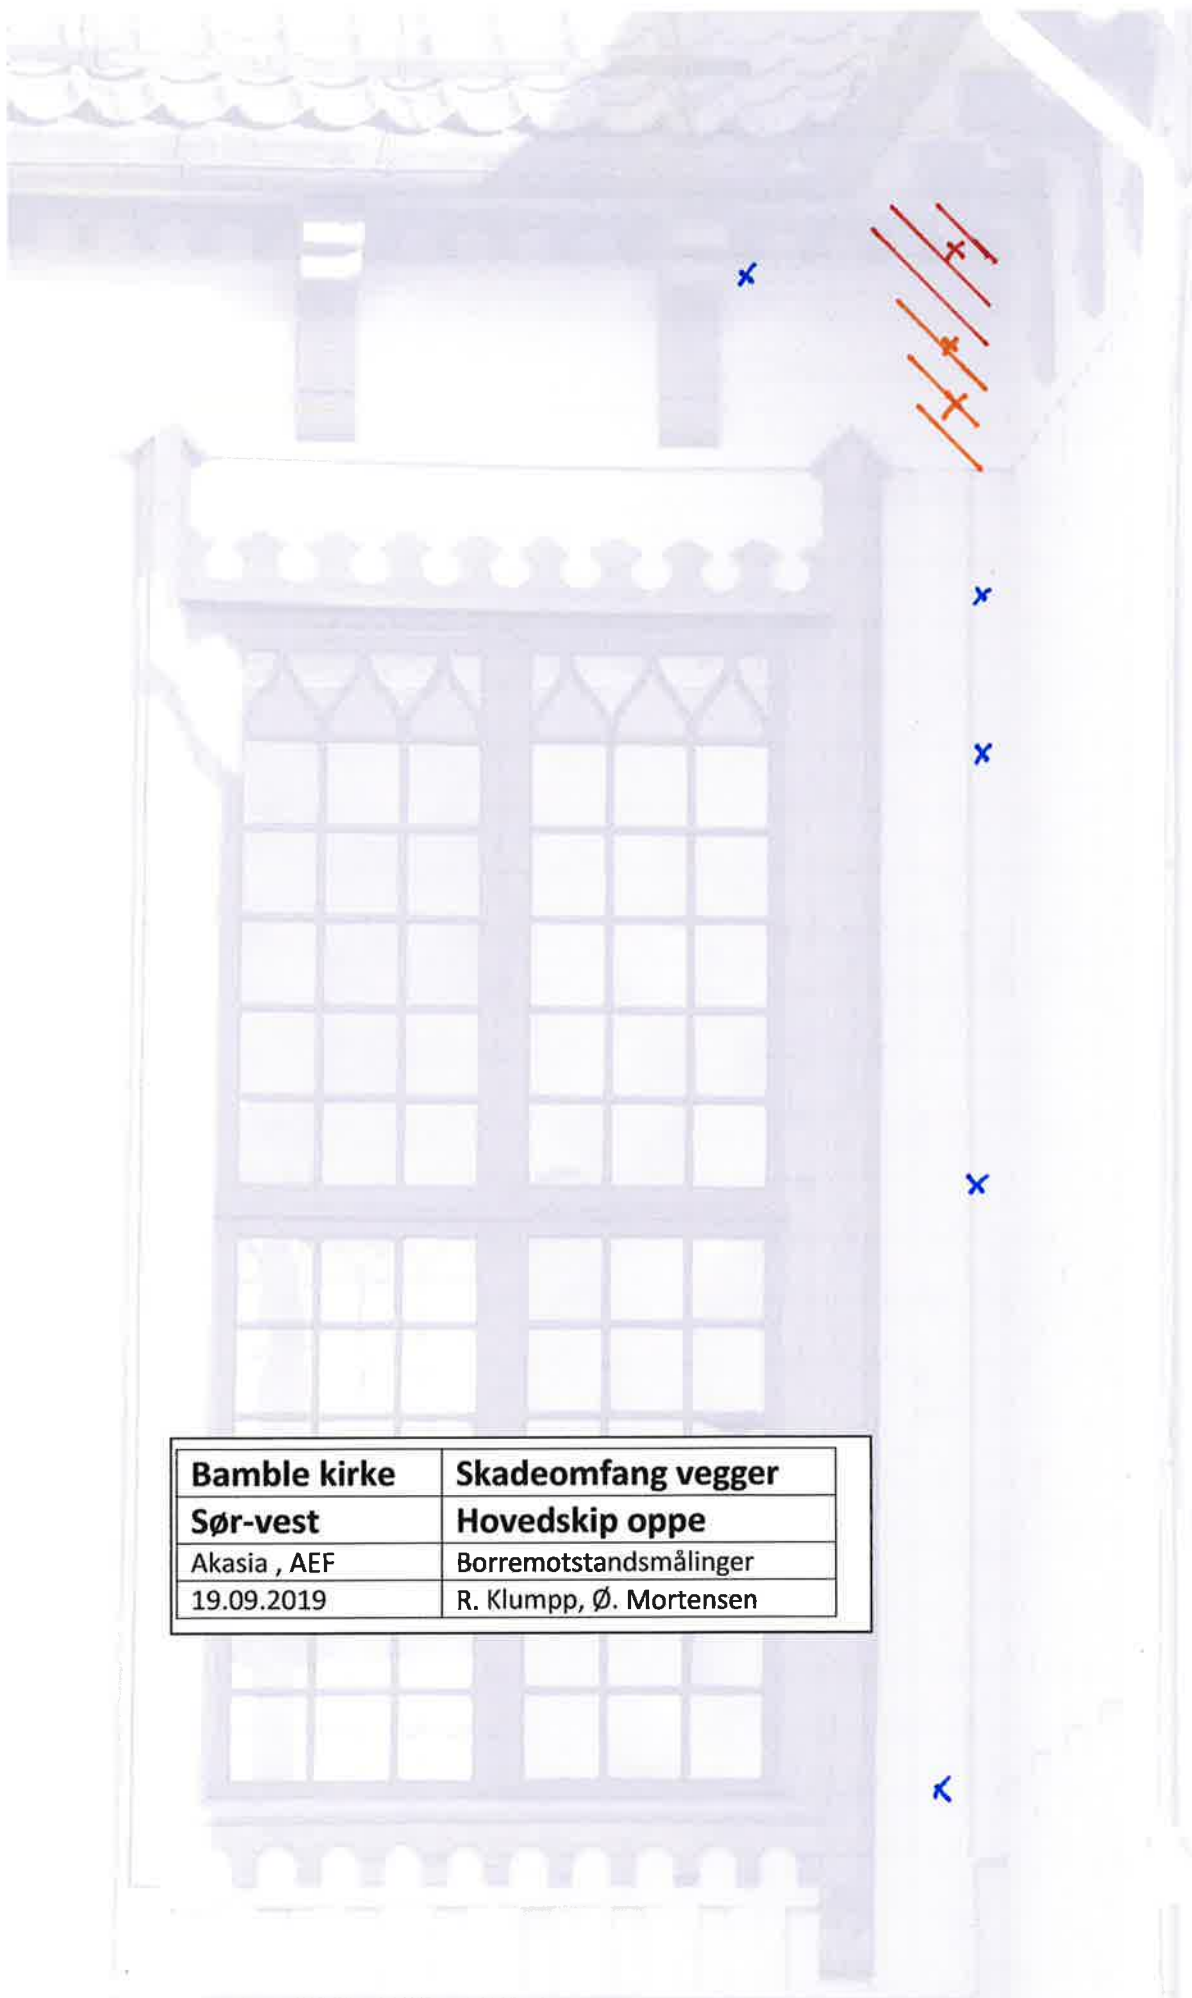
| <b>Sør-vest</b> | <b>Hovedskip oppe</b> |

| <b>Bamble kirke</b> | <b>Skadeomfang vegger</b> |
| Akasia , AEF | Borremotstandsmålinger |

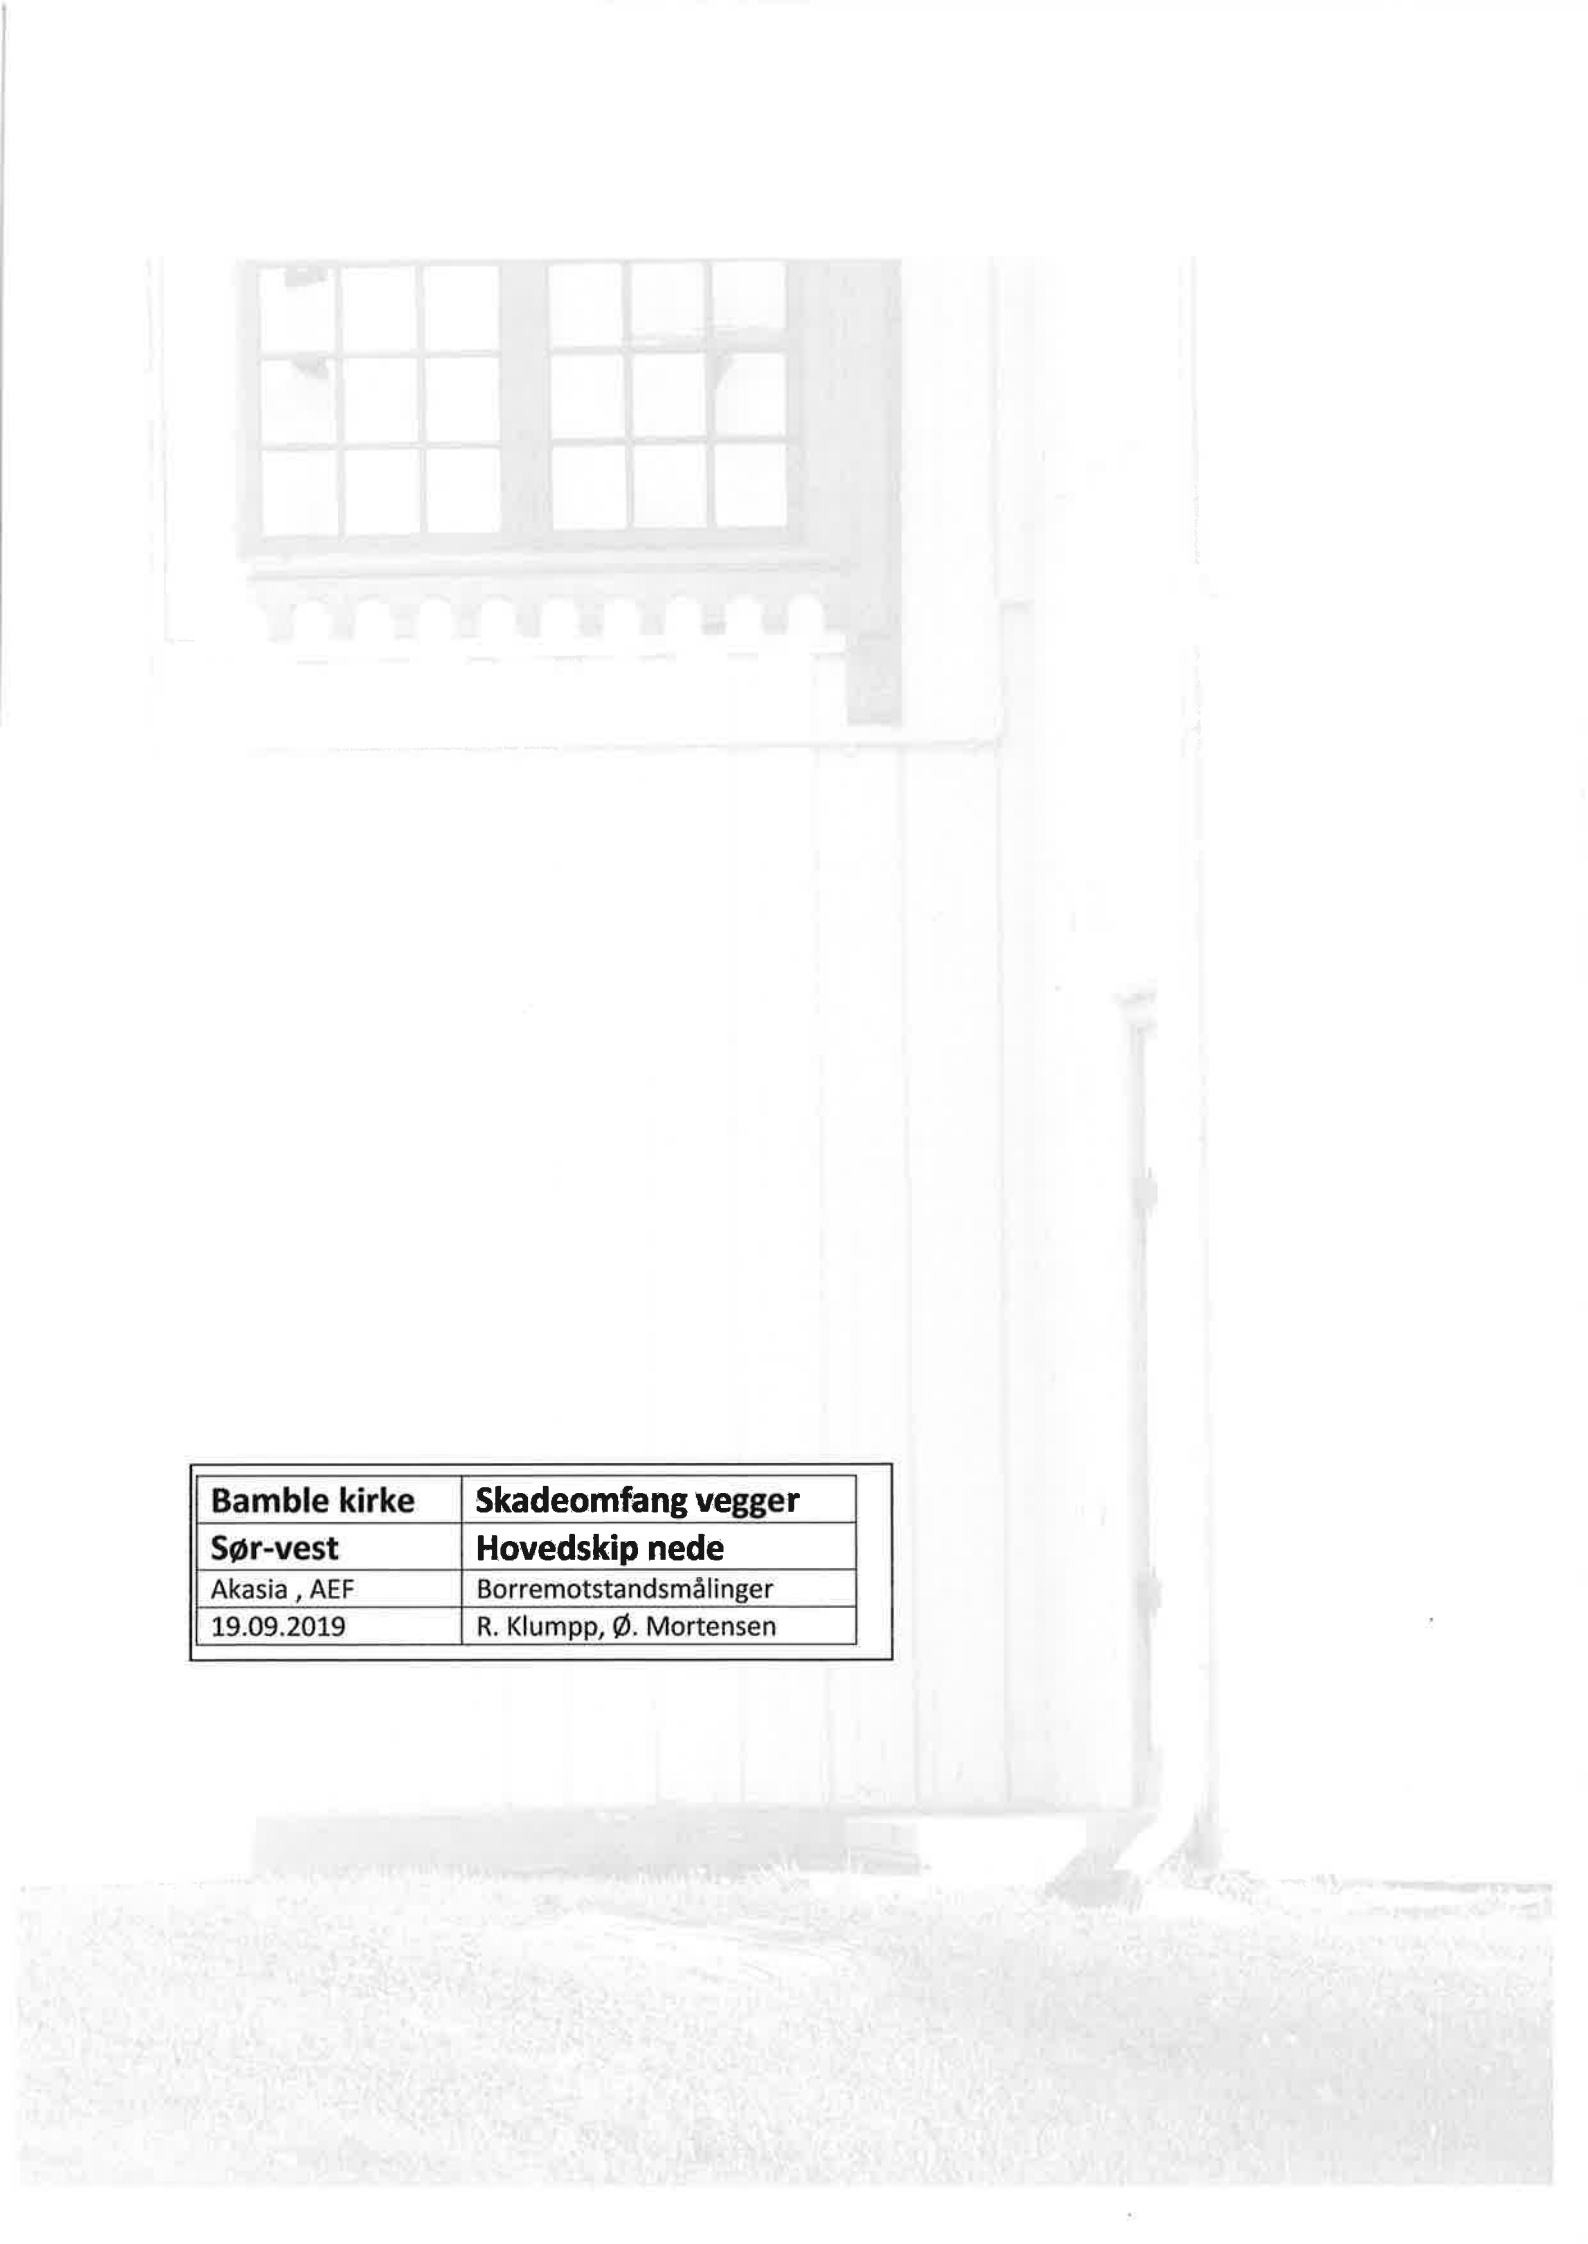
| <b>Sør-vest</b> | <b>Hovedskip nede</b> |

| <b>Bamble kirke</b> | <b>Skadeomfang vegger</b> |
| Akasia , AEF | Borremotstandsmålinger |

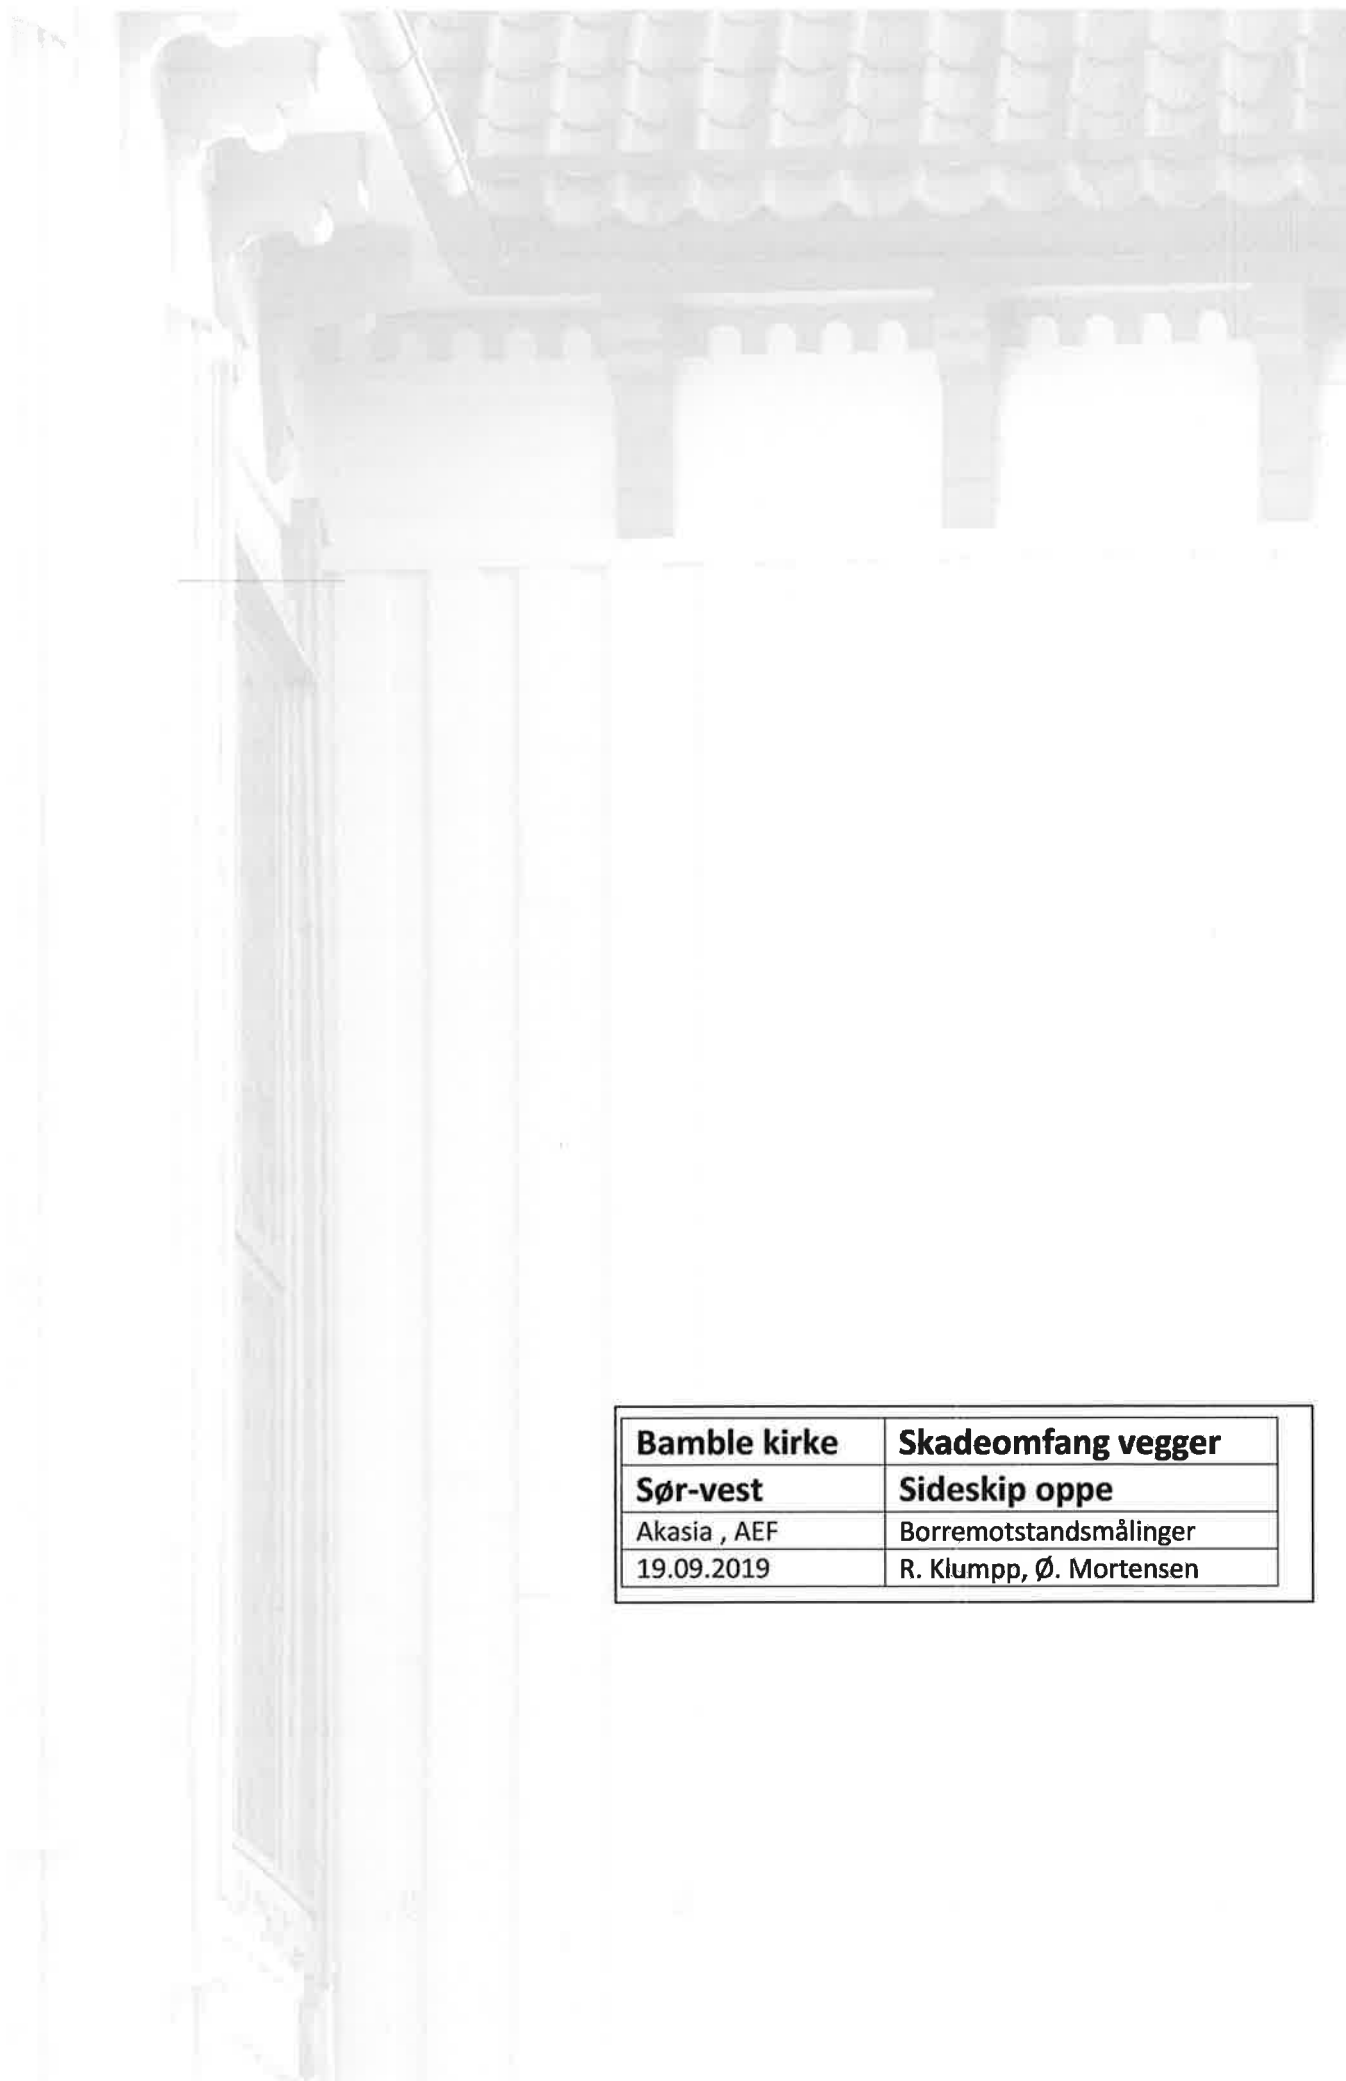
| <b>Sør-vest</b> | <b>Sideskip oppe</b> |

| <b>Bamble kirke</b> | <b>Skadeomfang vegger</b> |
| Akasia , AEF | Borremotstandsmålinger |

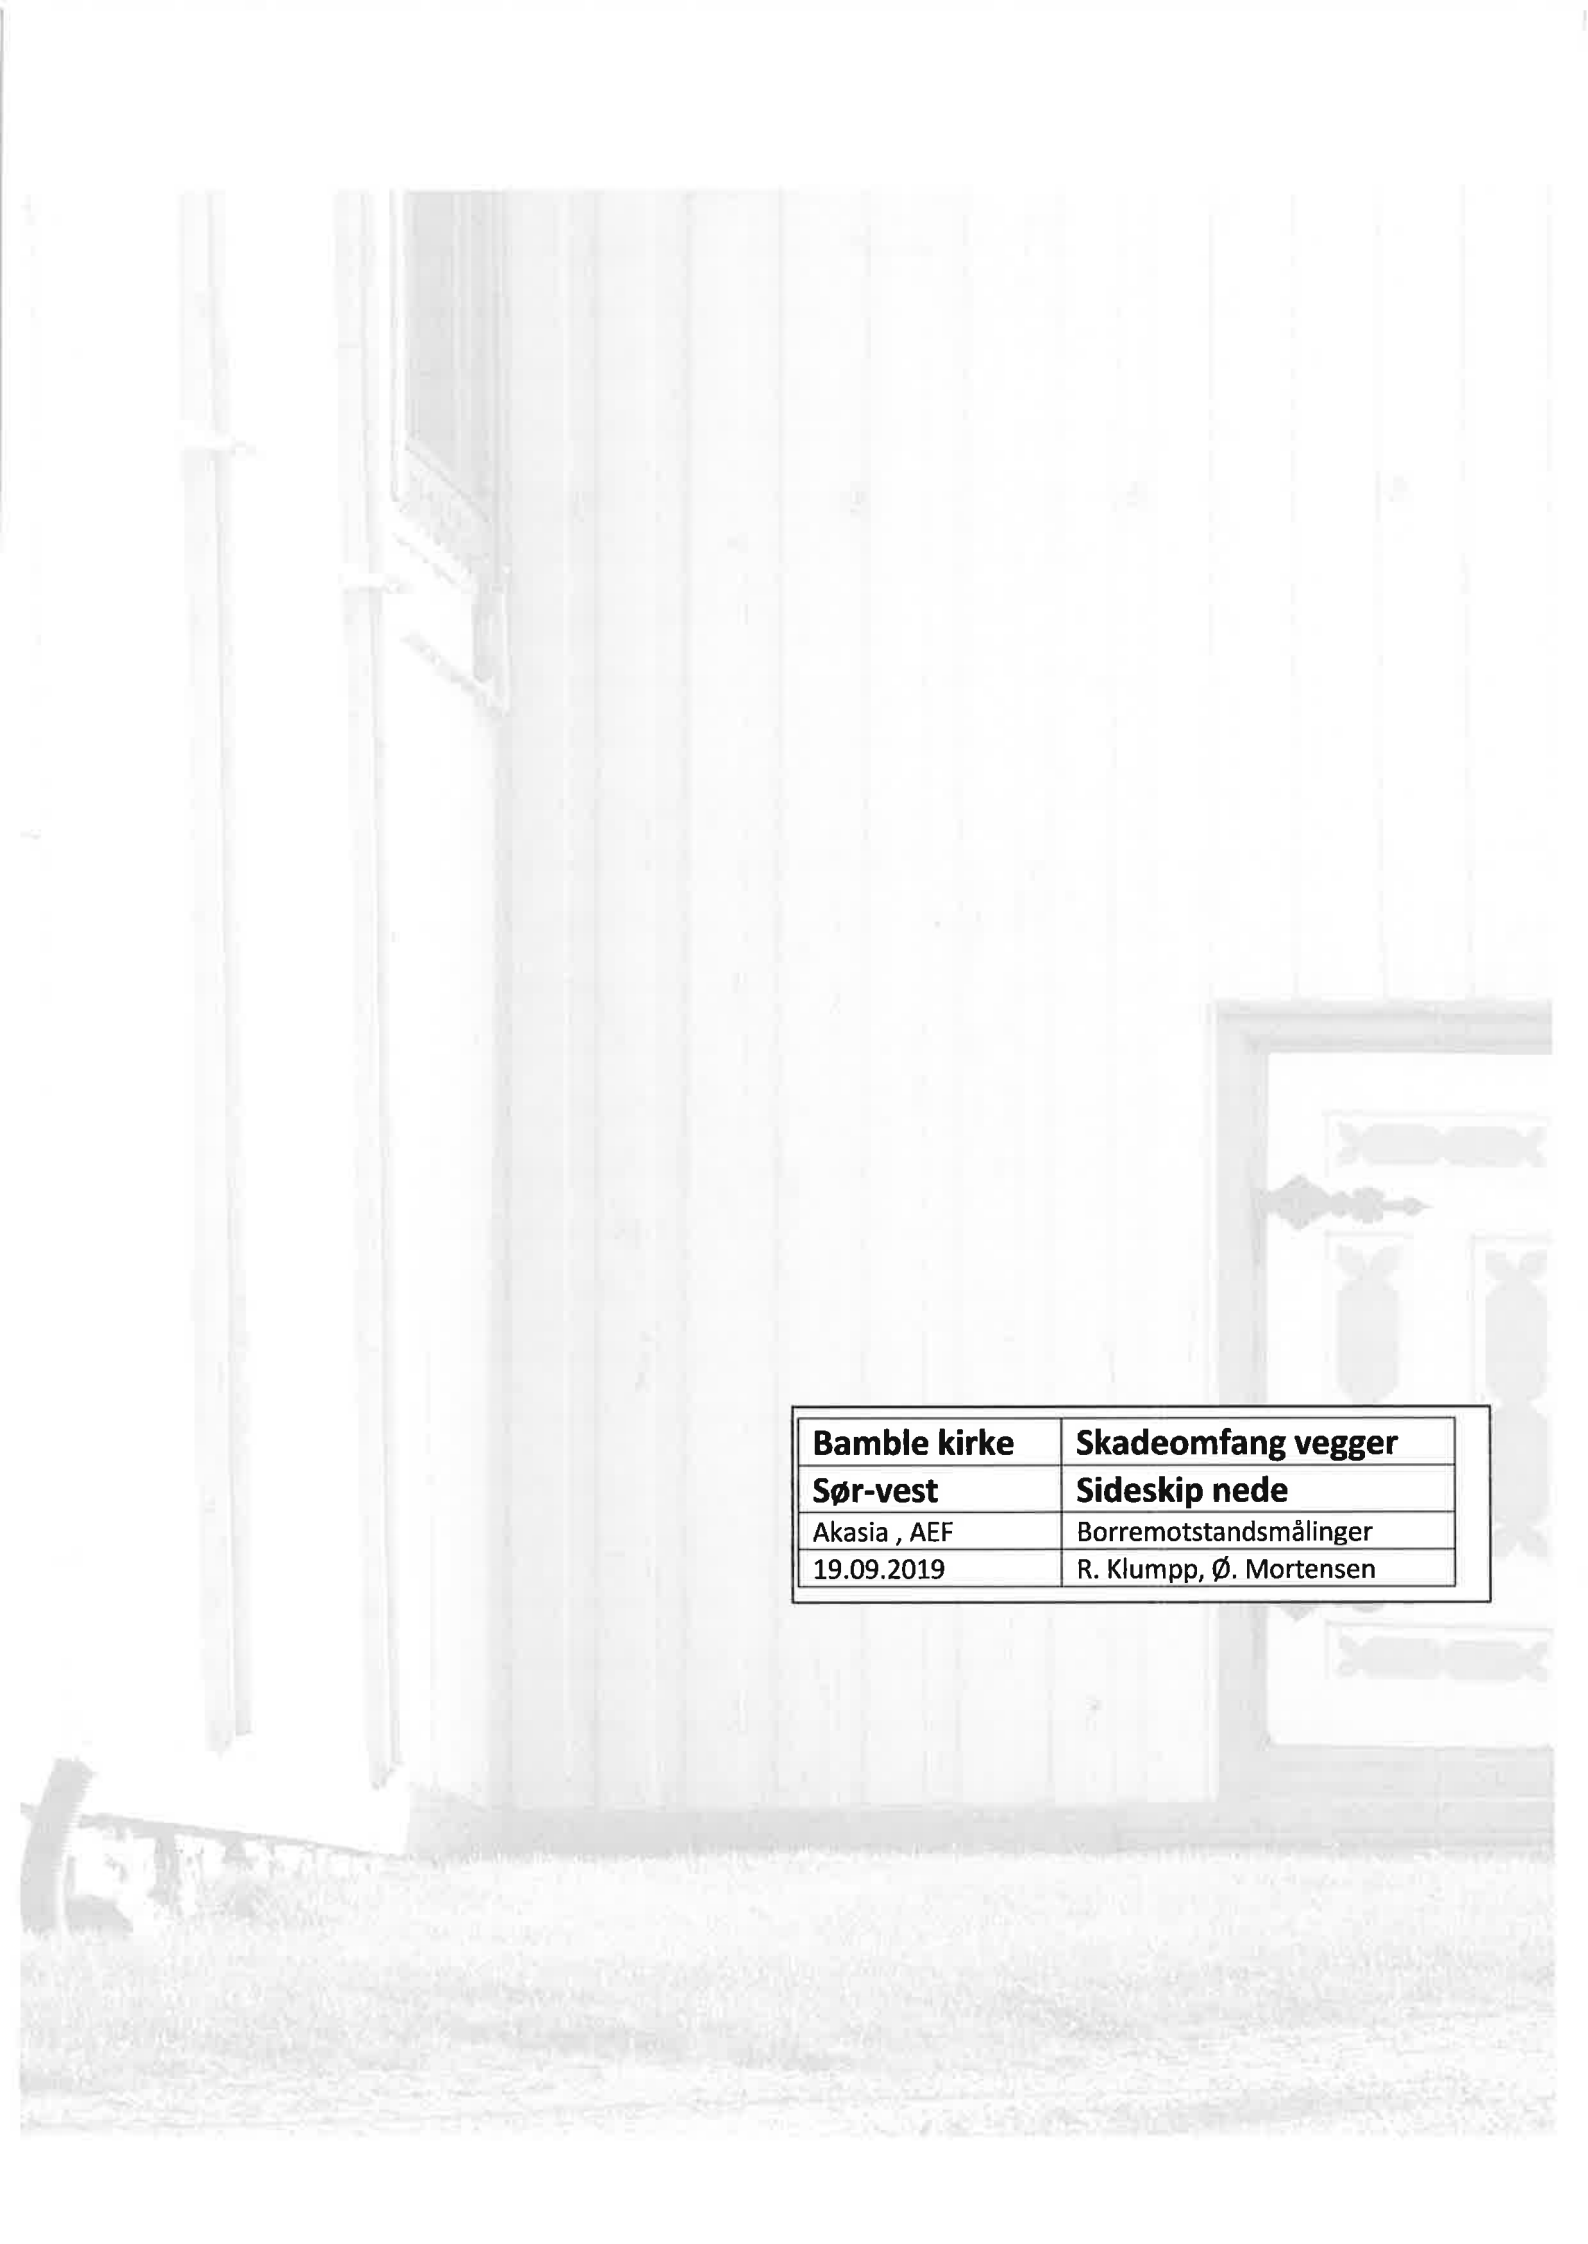
| <b>Sør-vest</b> | <b>Sideskip nede</b> |

| <b>Bamble kirke</b> | <b>Skadeomfang vegger</b> |
| Akasia , AEF | Borremotstandsmålinger |

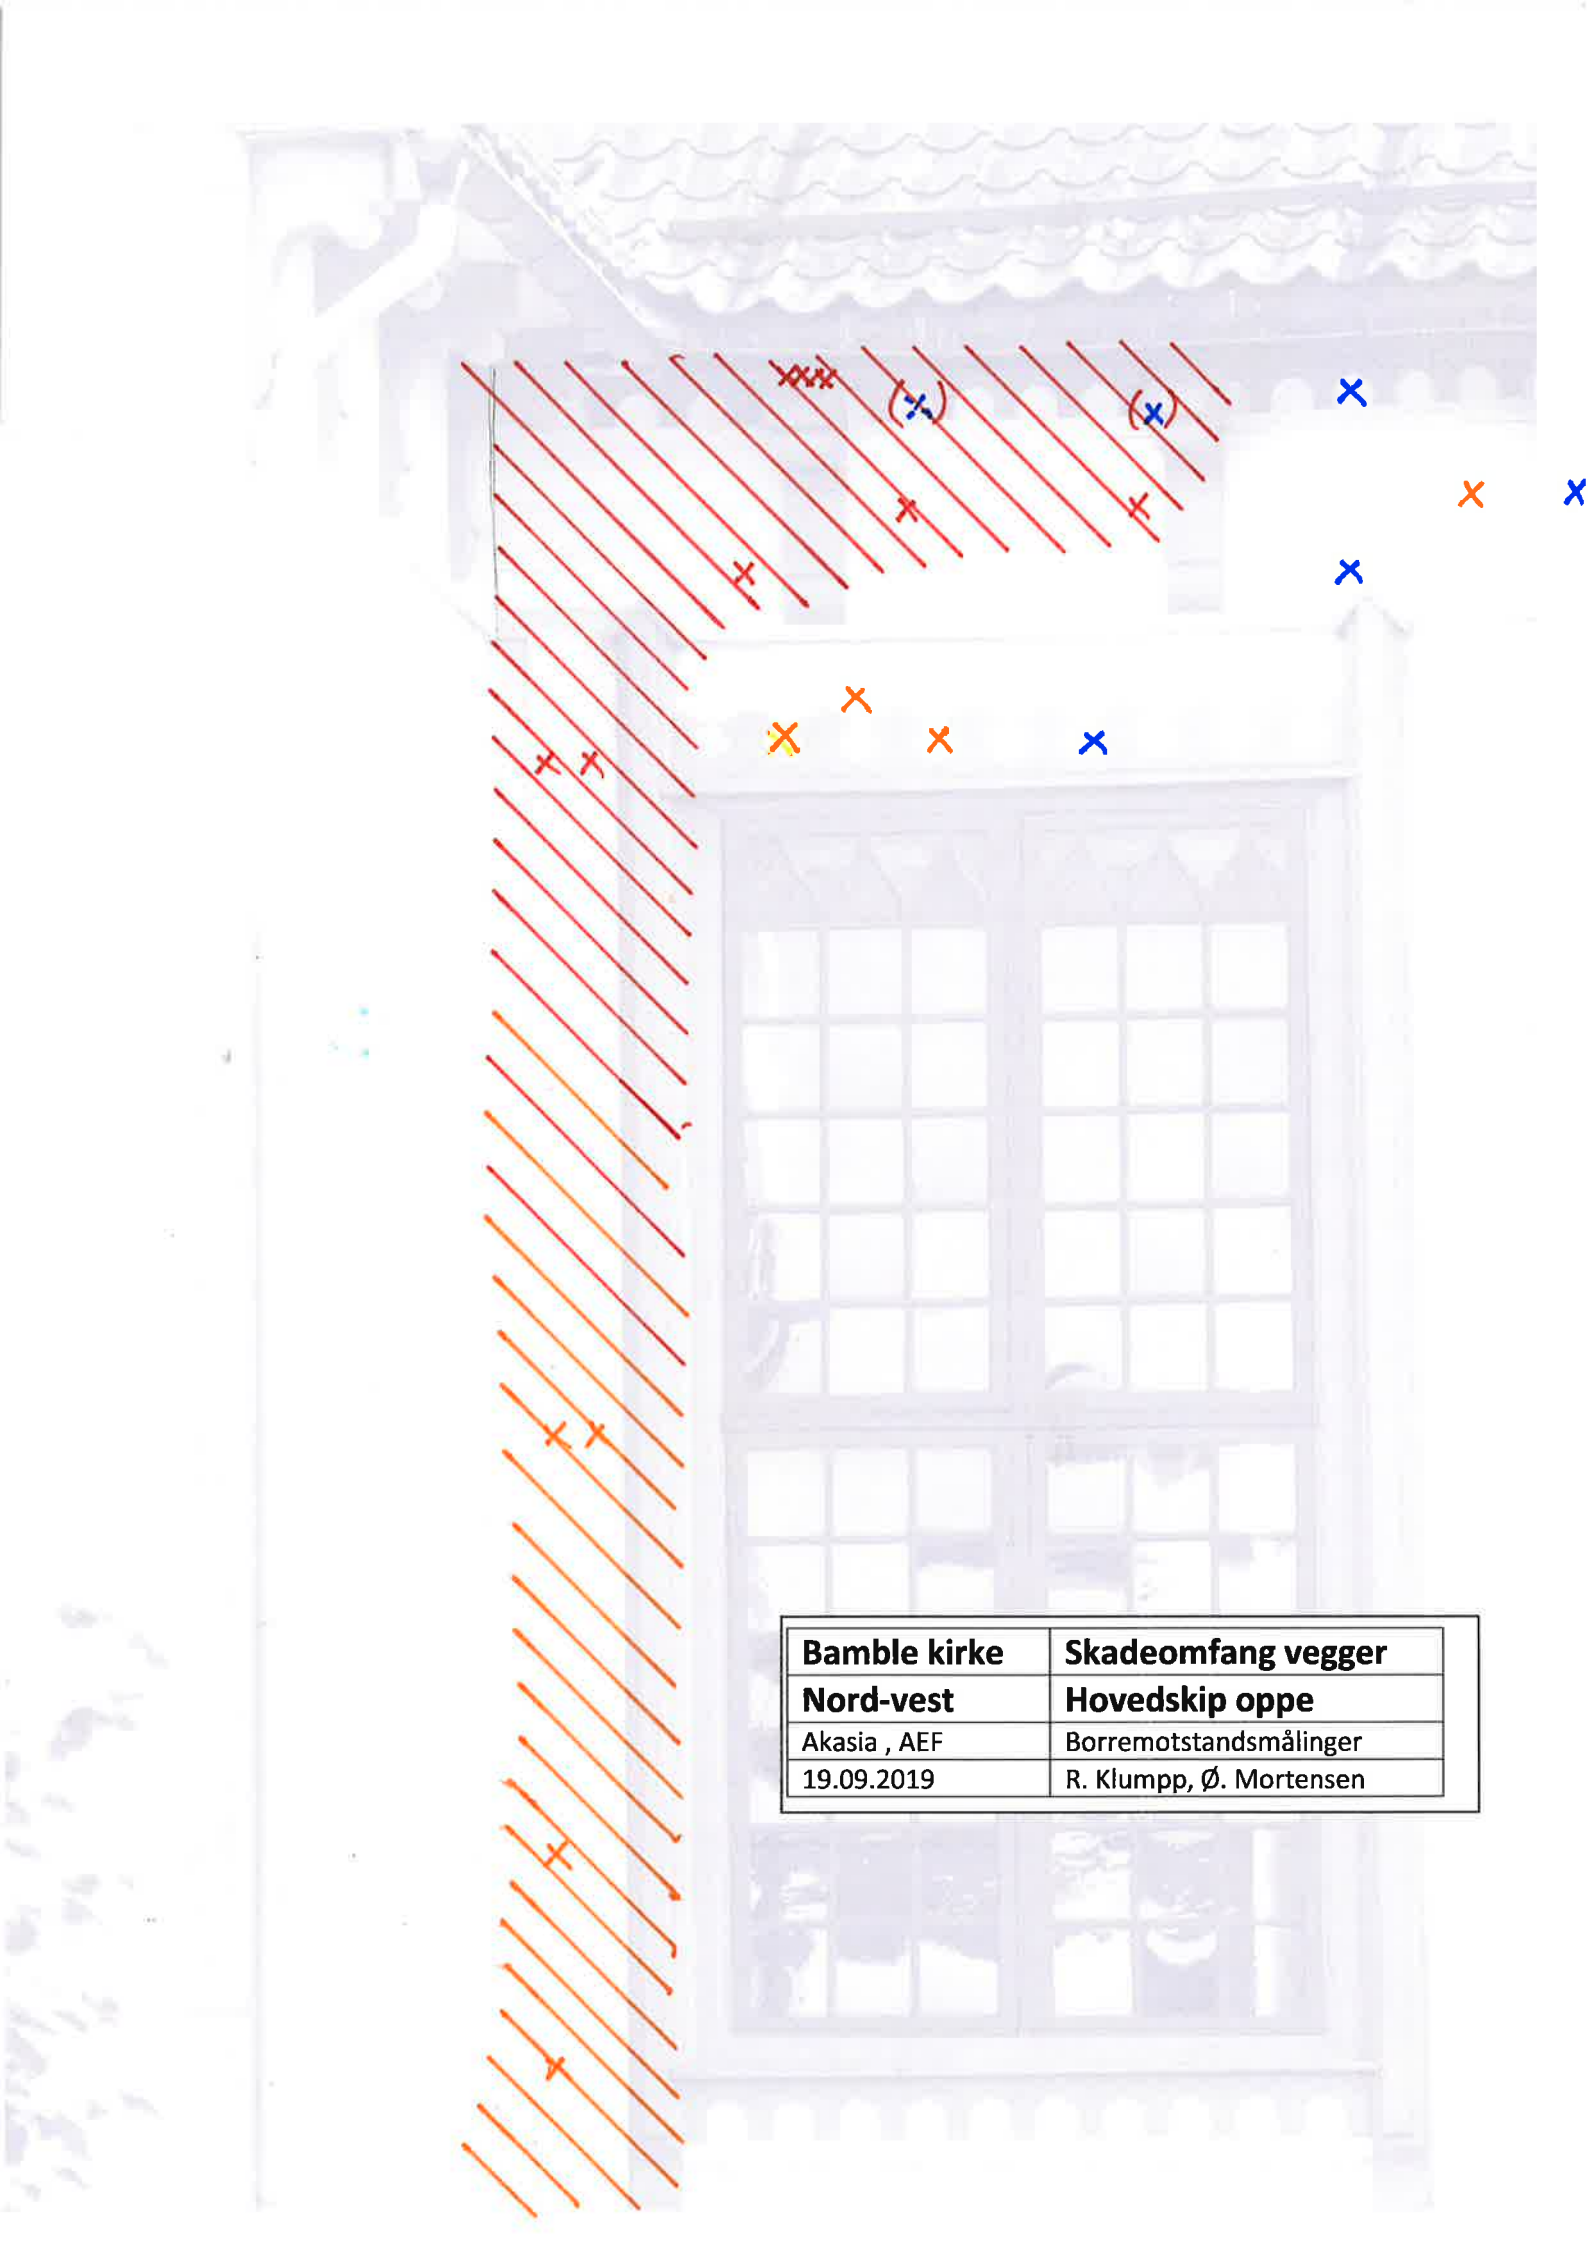
| <b>Nord-vest</b> | <b>Hovedskip oppe</b> |

| <b>Bamble kirke</b> | <b>Skadeomfang vegger</b> |
| Akasia , AEF | Borremotstandsmålinger |

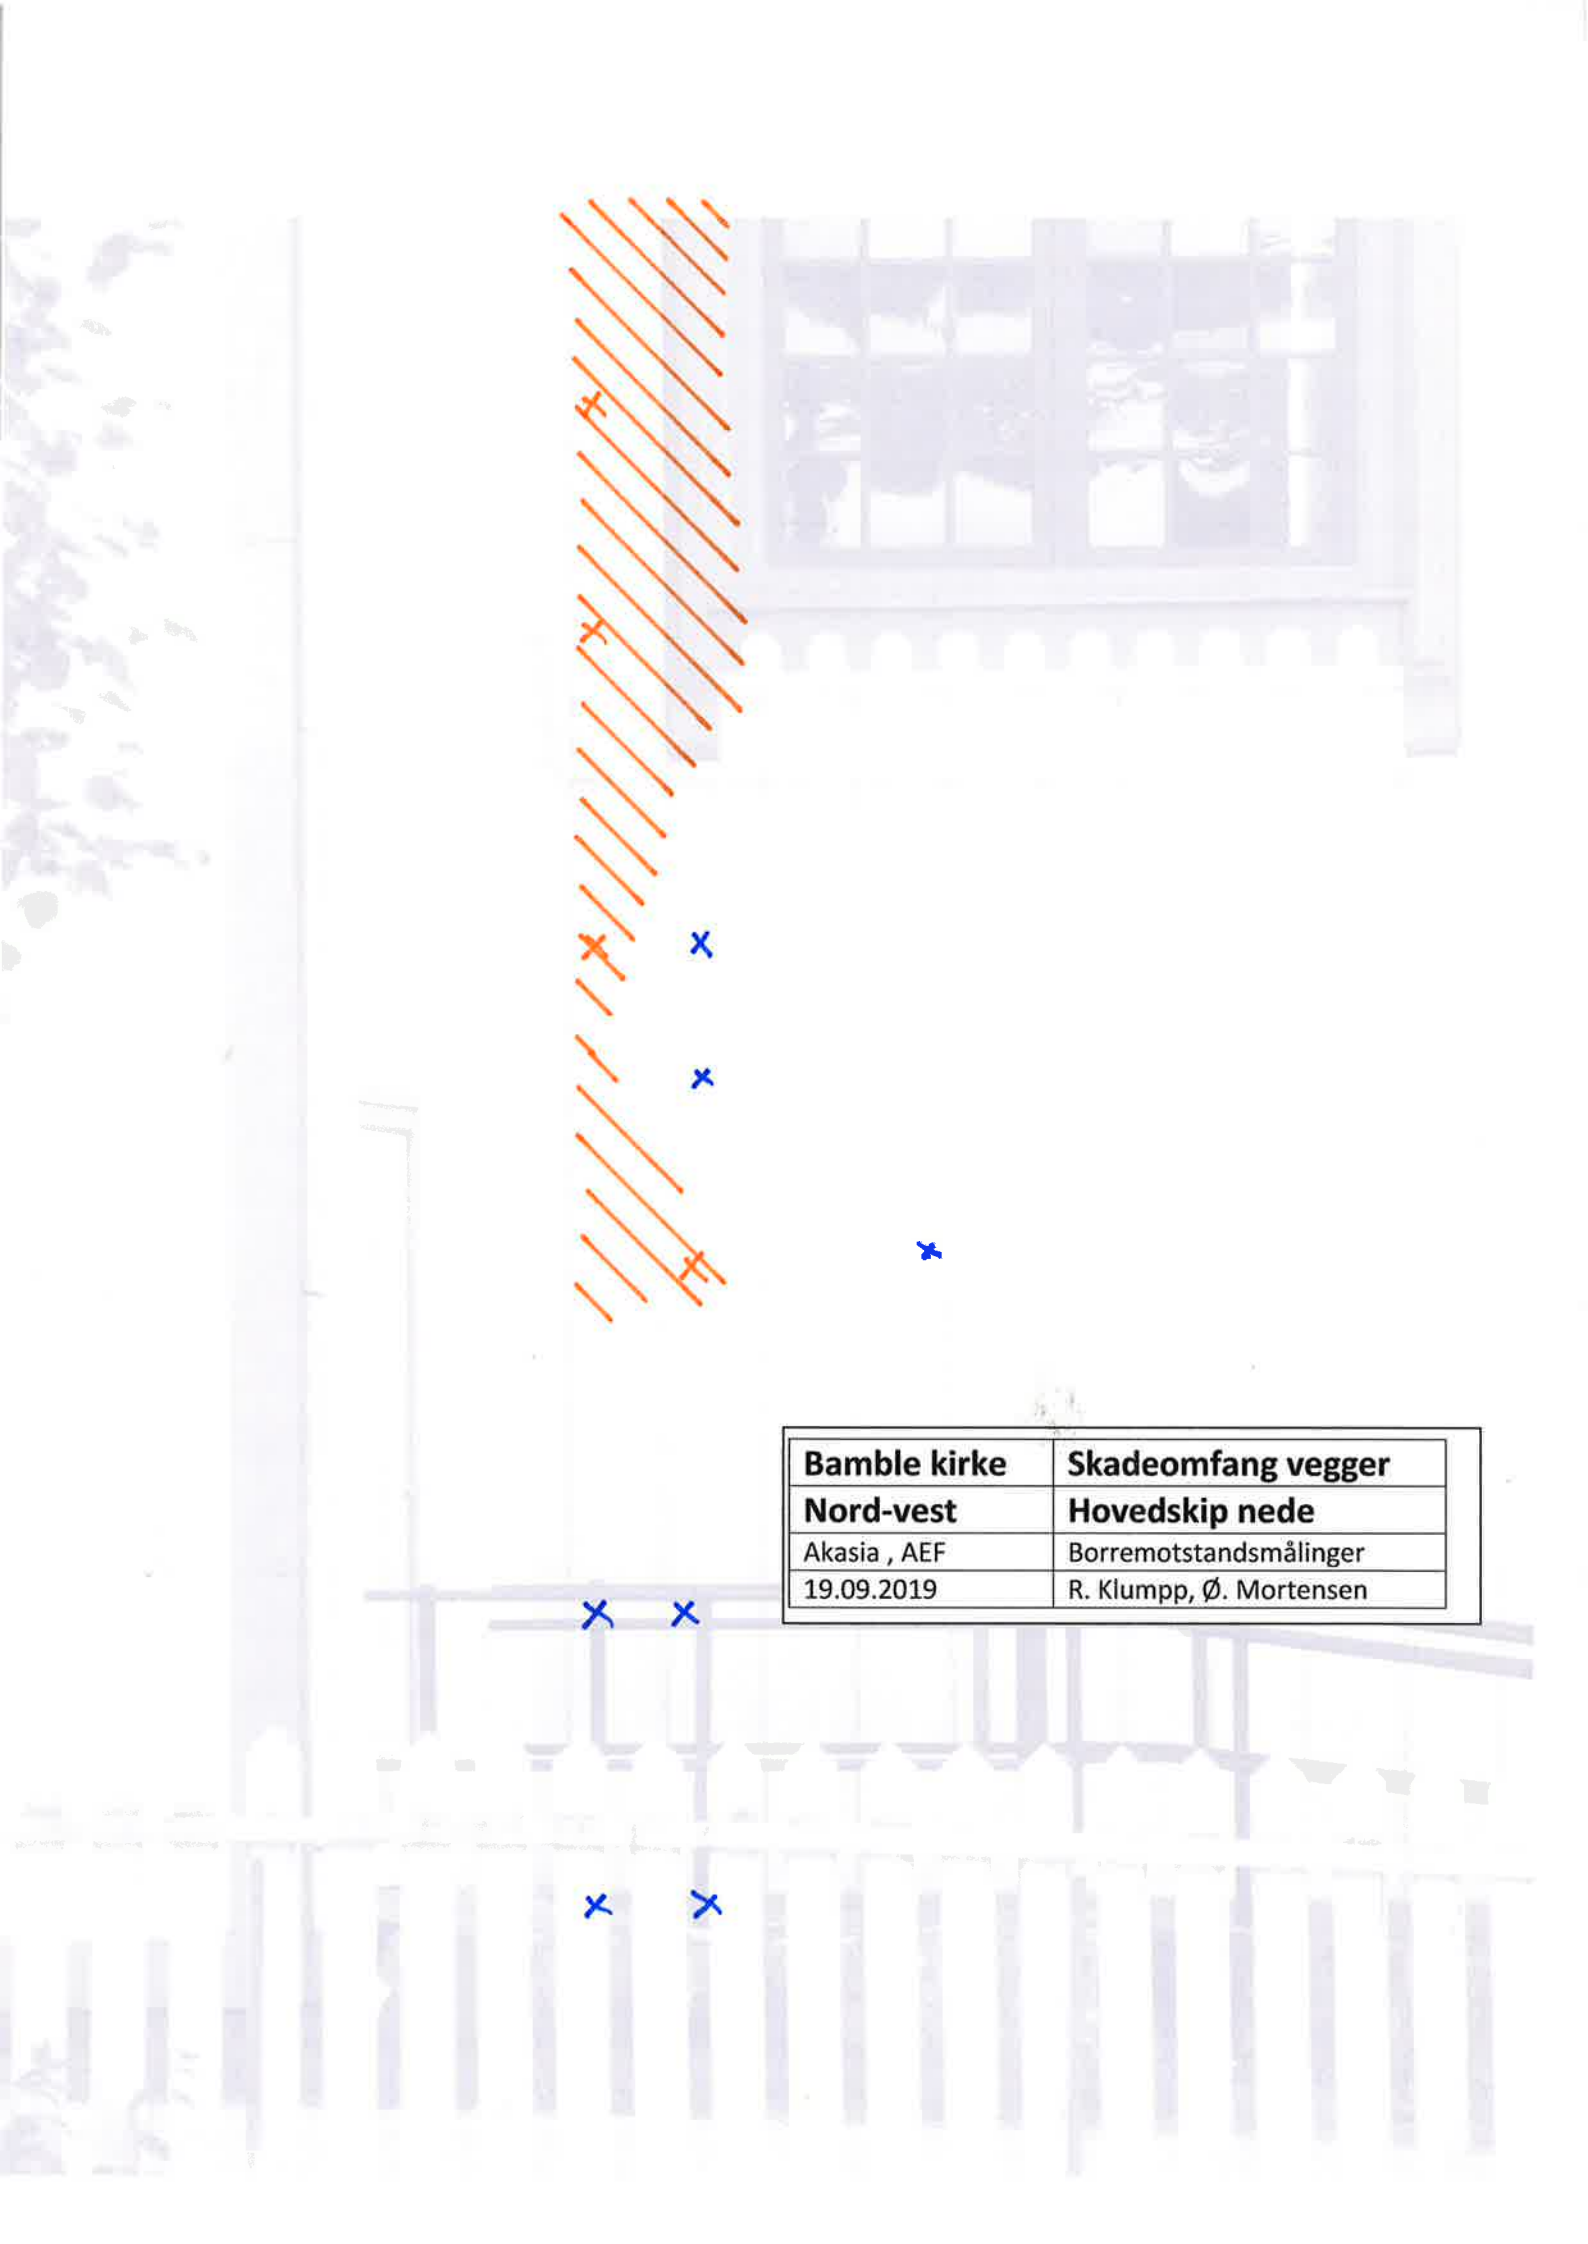
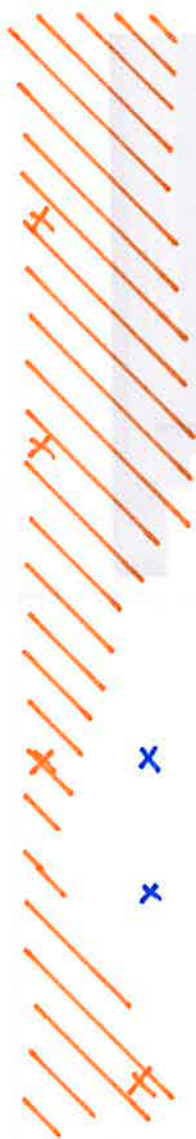
| <b>Nord-vest</b> | <b>Hovedskip nede</b> |

| <b>Bamble kirke</b> | <b>Skadeomfang vegger</b> |
| Akasia , AEF | Borremotstandsmålinger |
