| <b>Bamble kirke</b> | <b>Skadeomfang vegger</b> |
| Akasia , AEF | Borremotstandsmålinger |
| 19.09.2019 | R. Klumpp, Ø. Mortensen |

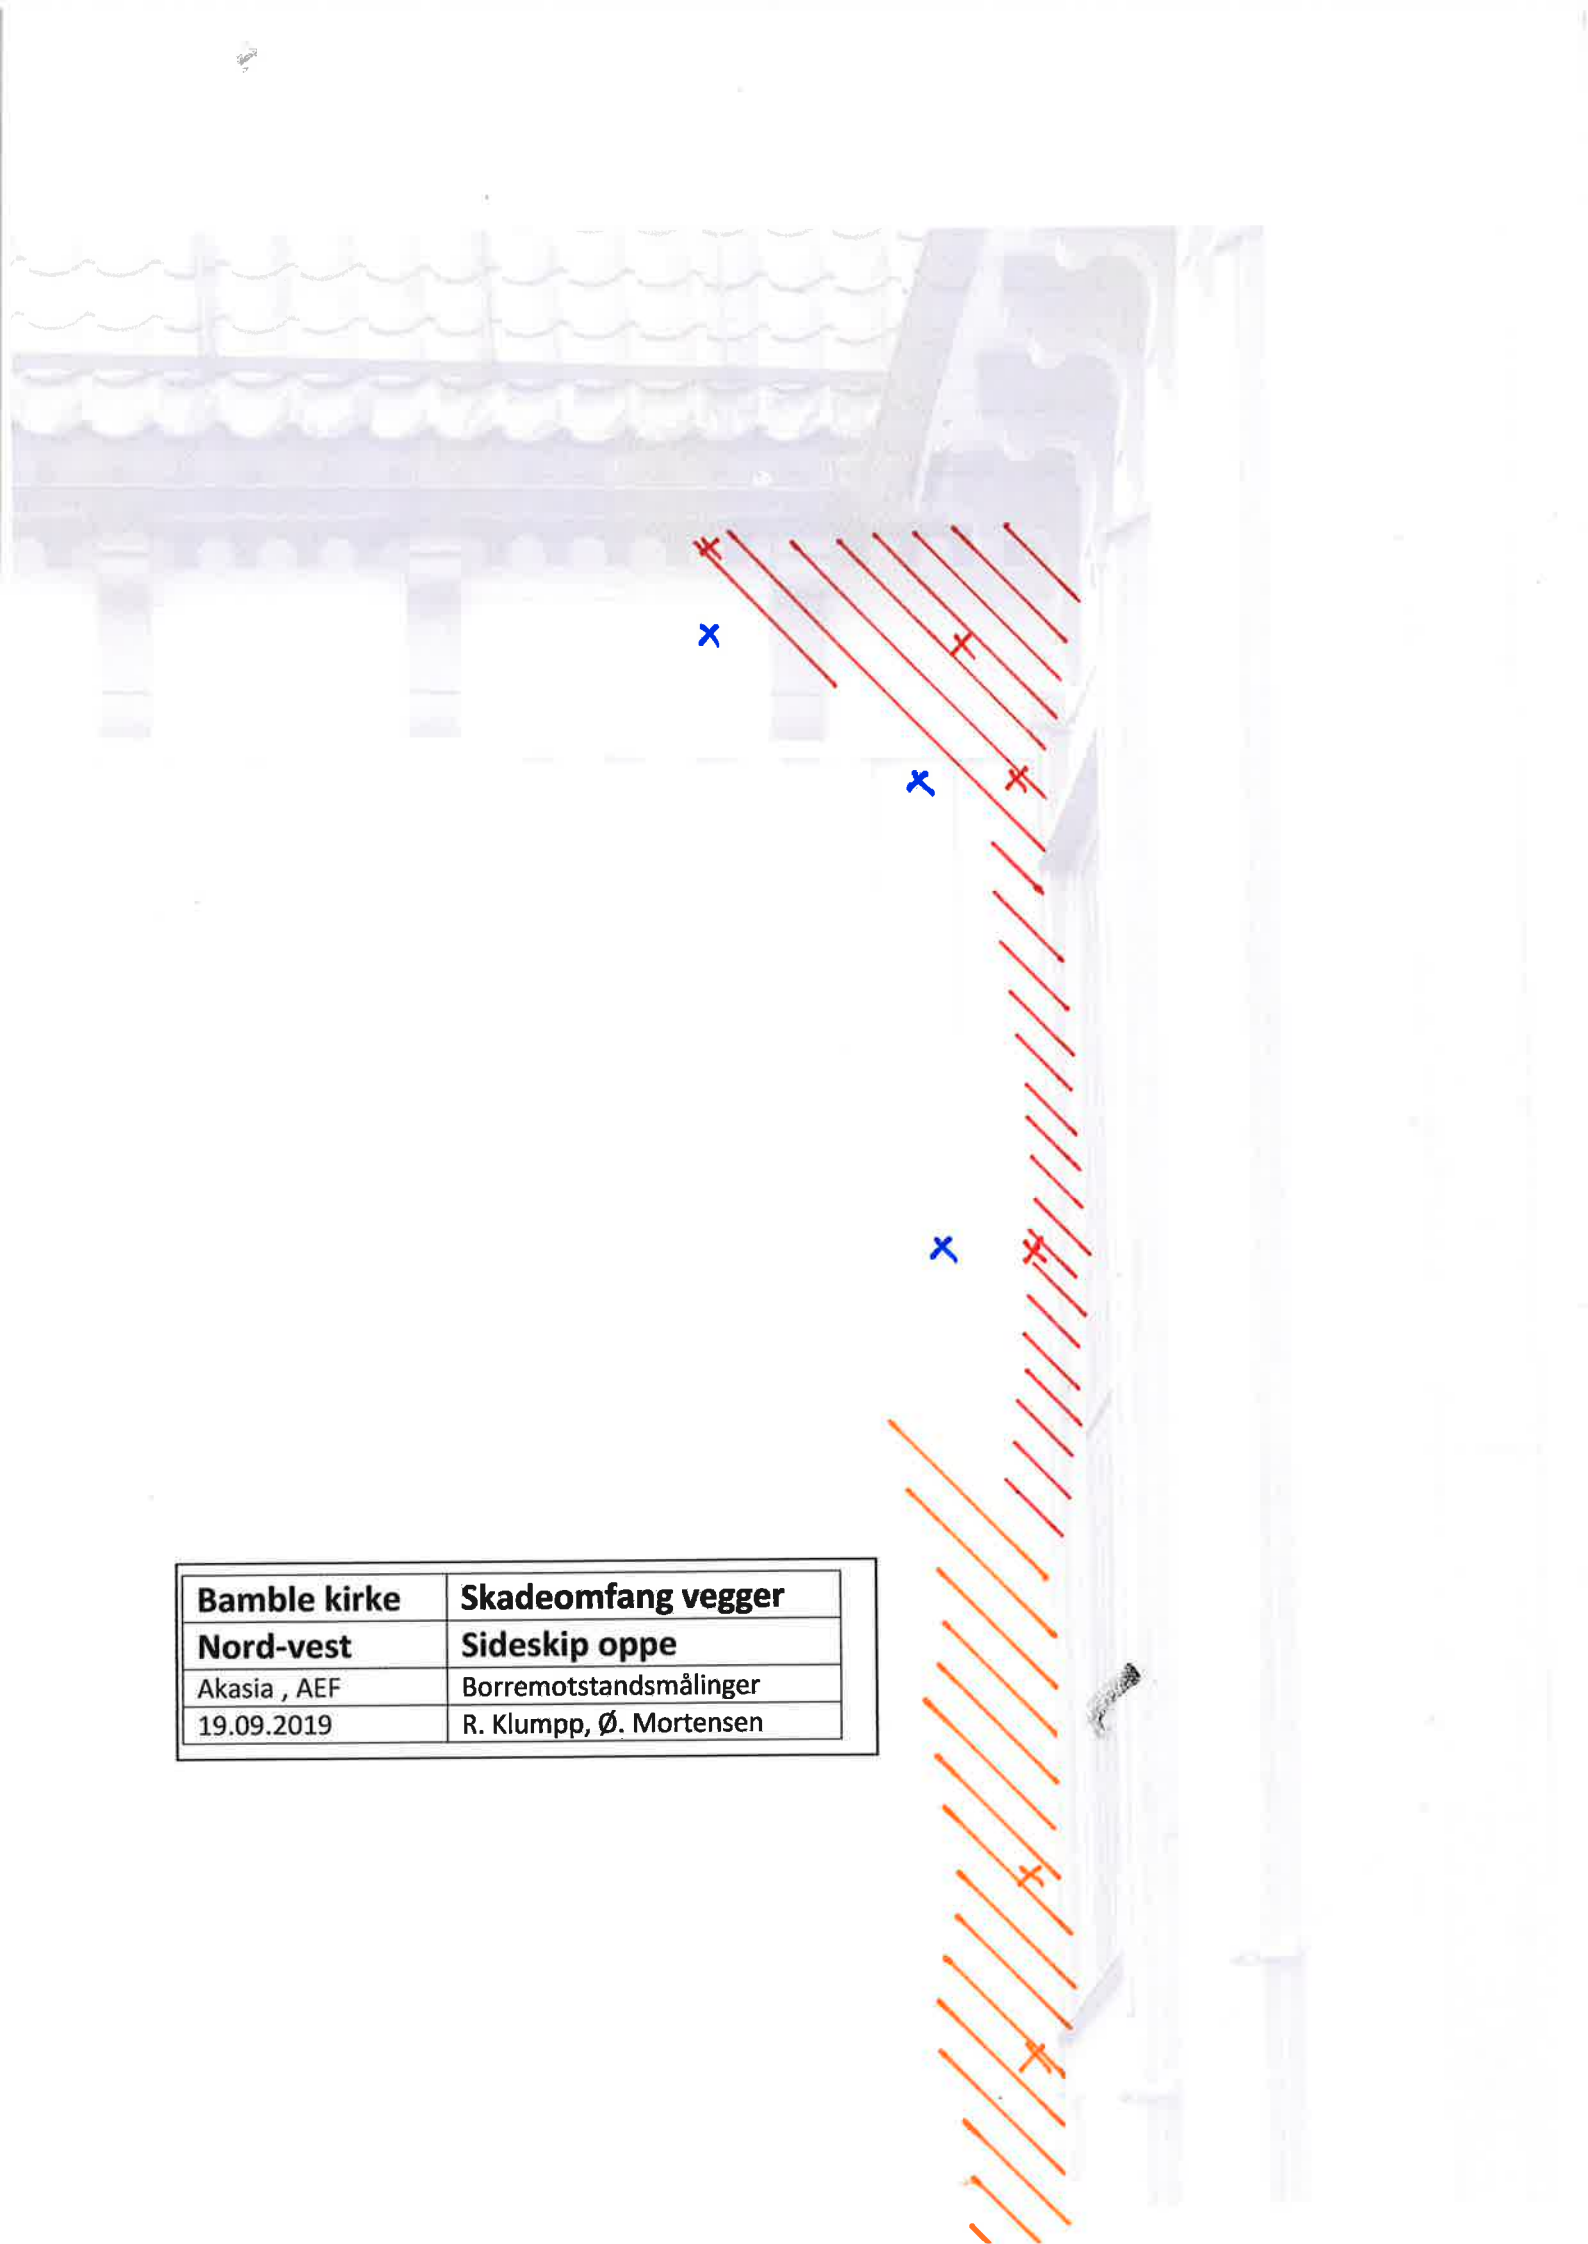
| <b>Nord-vest</b> | <b>Sideskip oppe</b> |

| <b>Bamble kirke</b> | <b>Skadeomfang vegger</b> |
| Akasia , AEF | Borremotstandsmålinger |

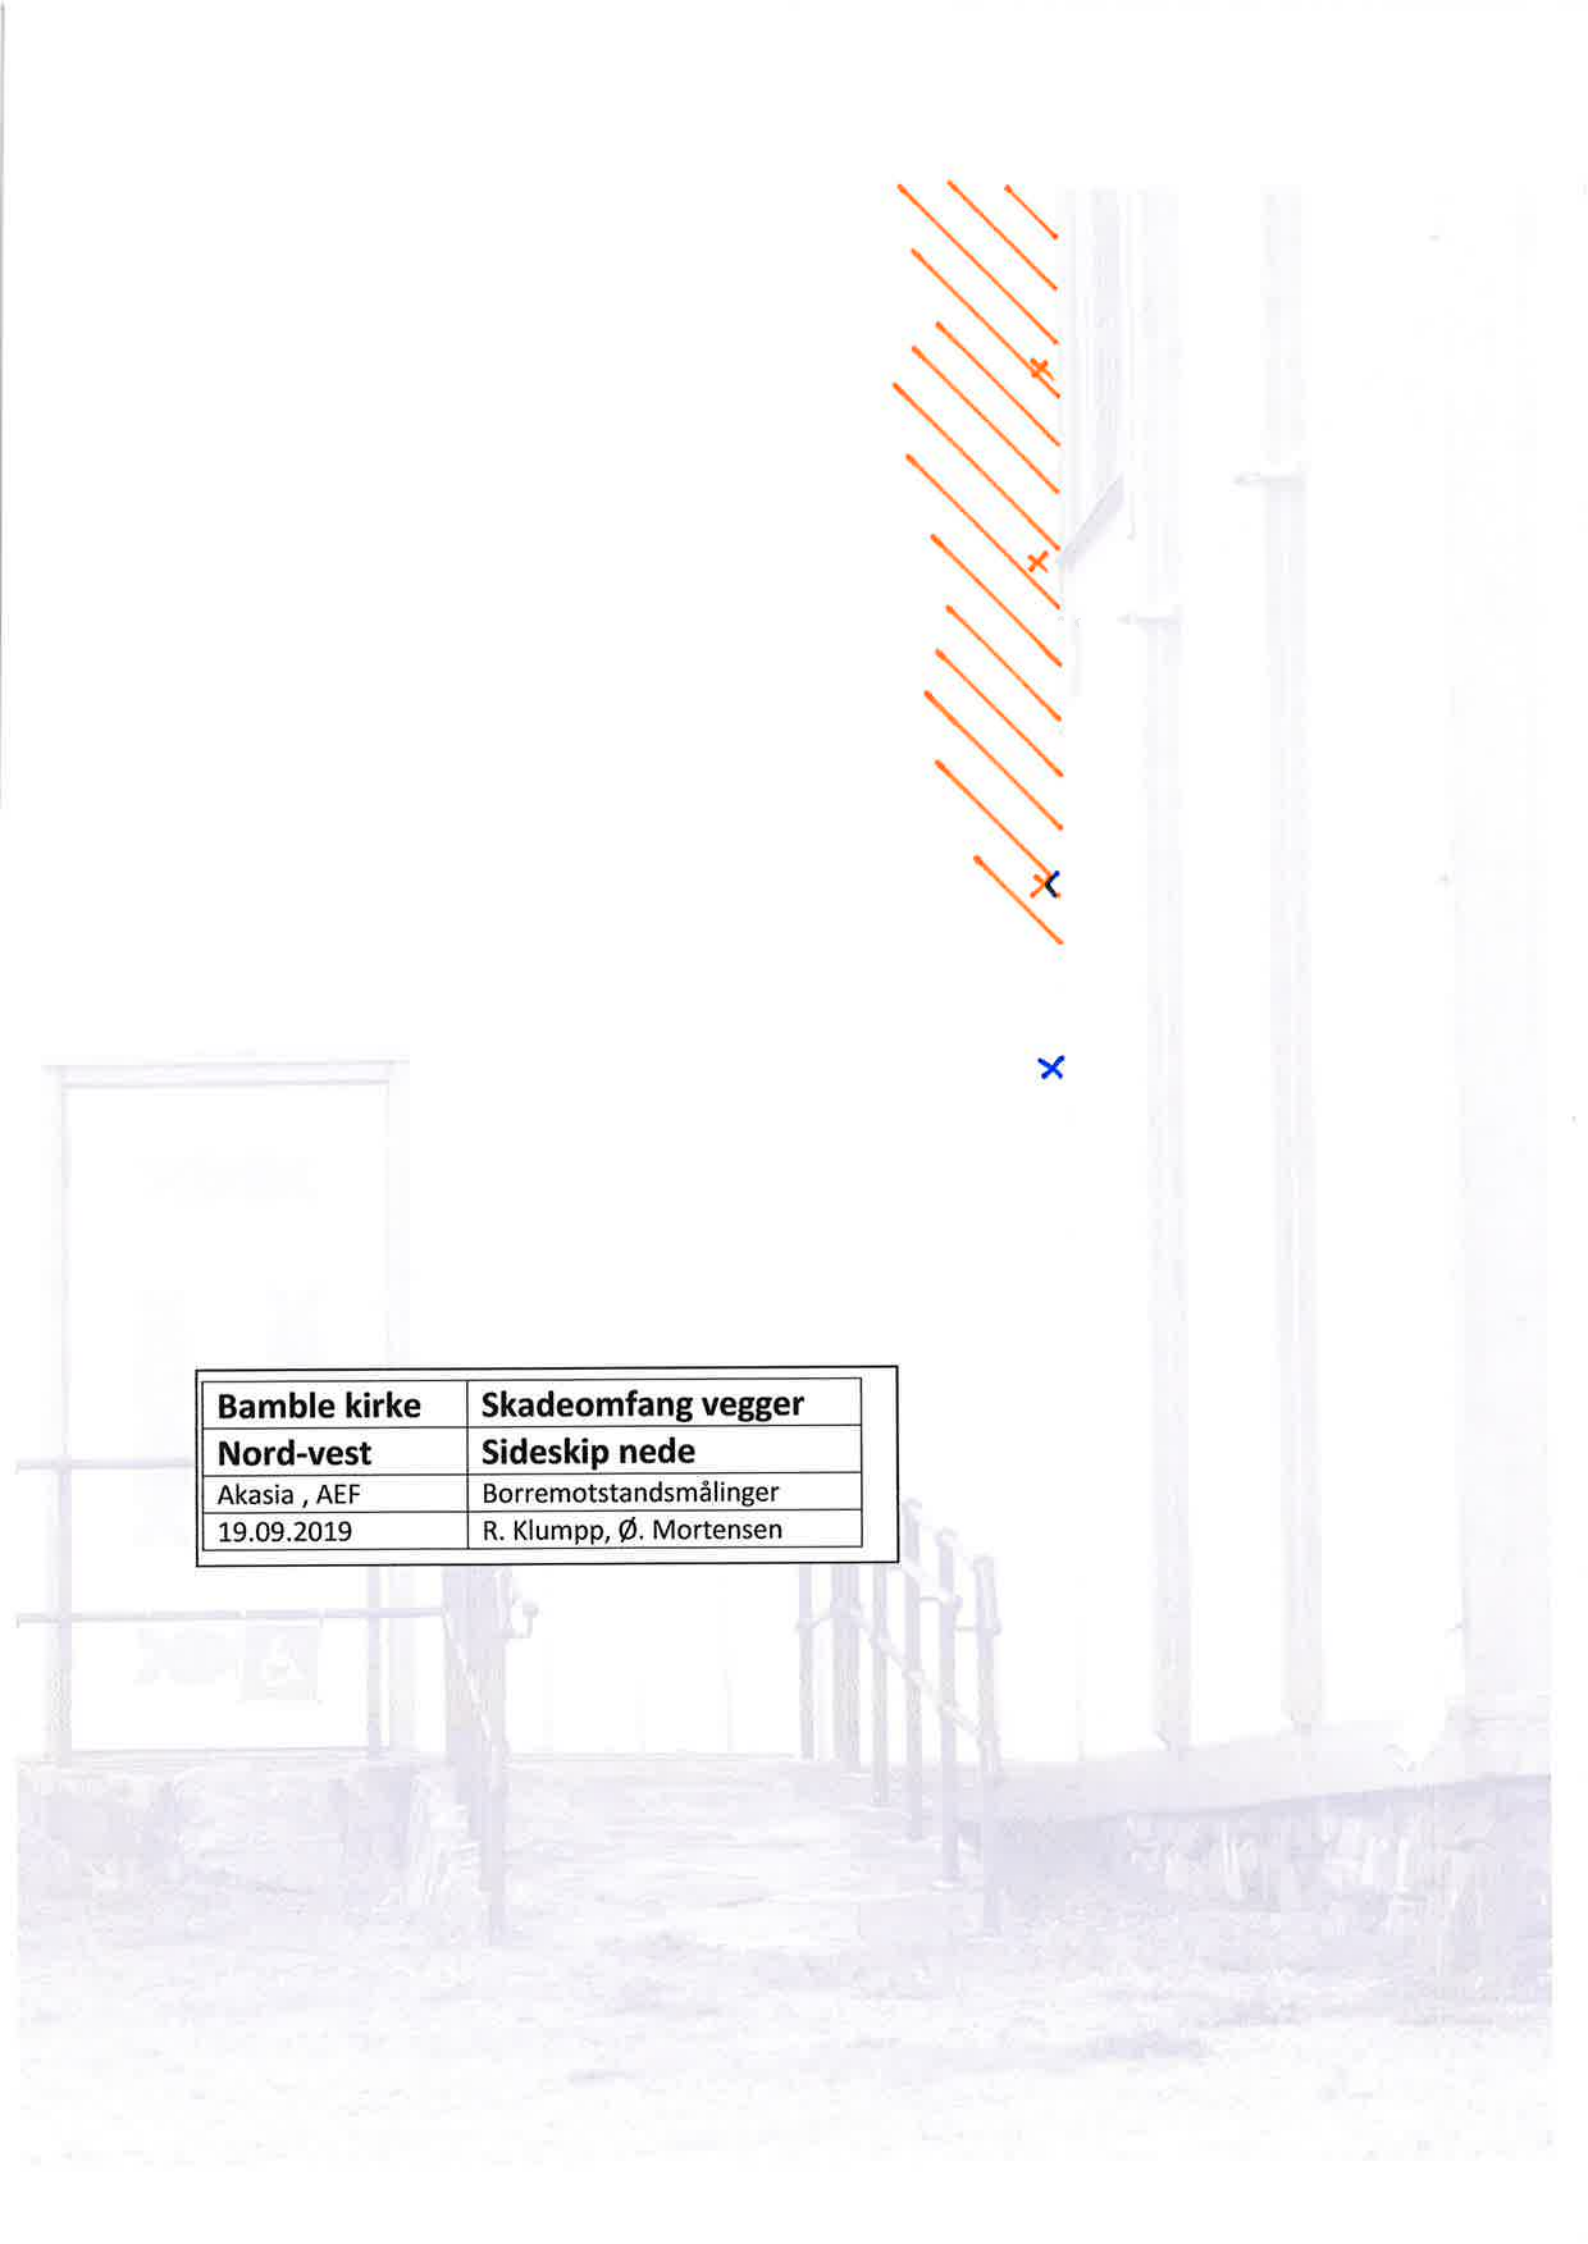
| <b>Nord-vest</b> | <b>Sideskip nede</b> |

| <b>Bamble kirke</b> | <b>Skadeomfang vegger</b> |
| Akasia , AEF | Borremotstandsmålinger |

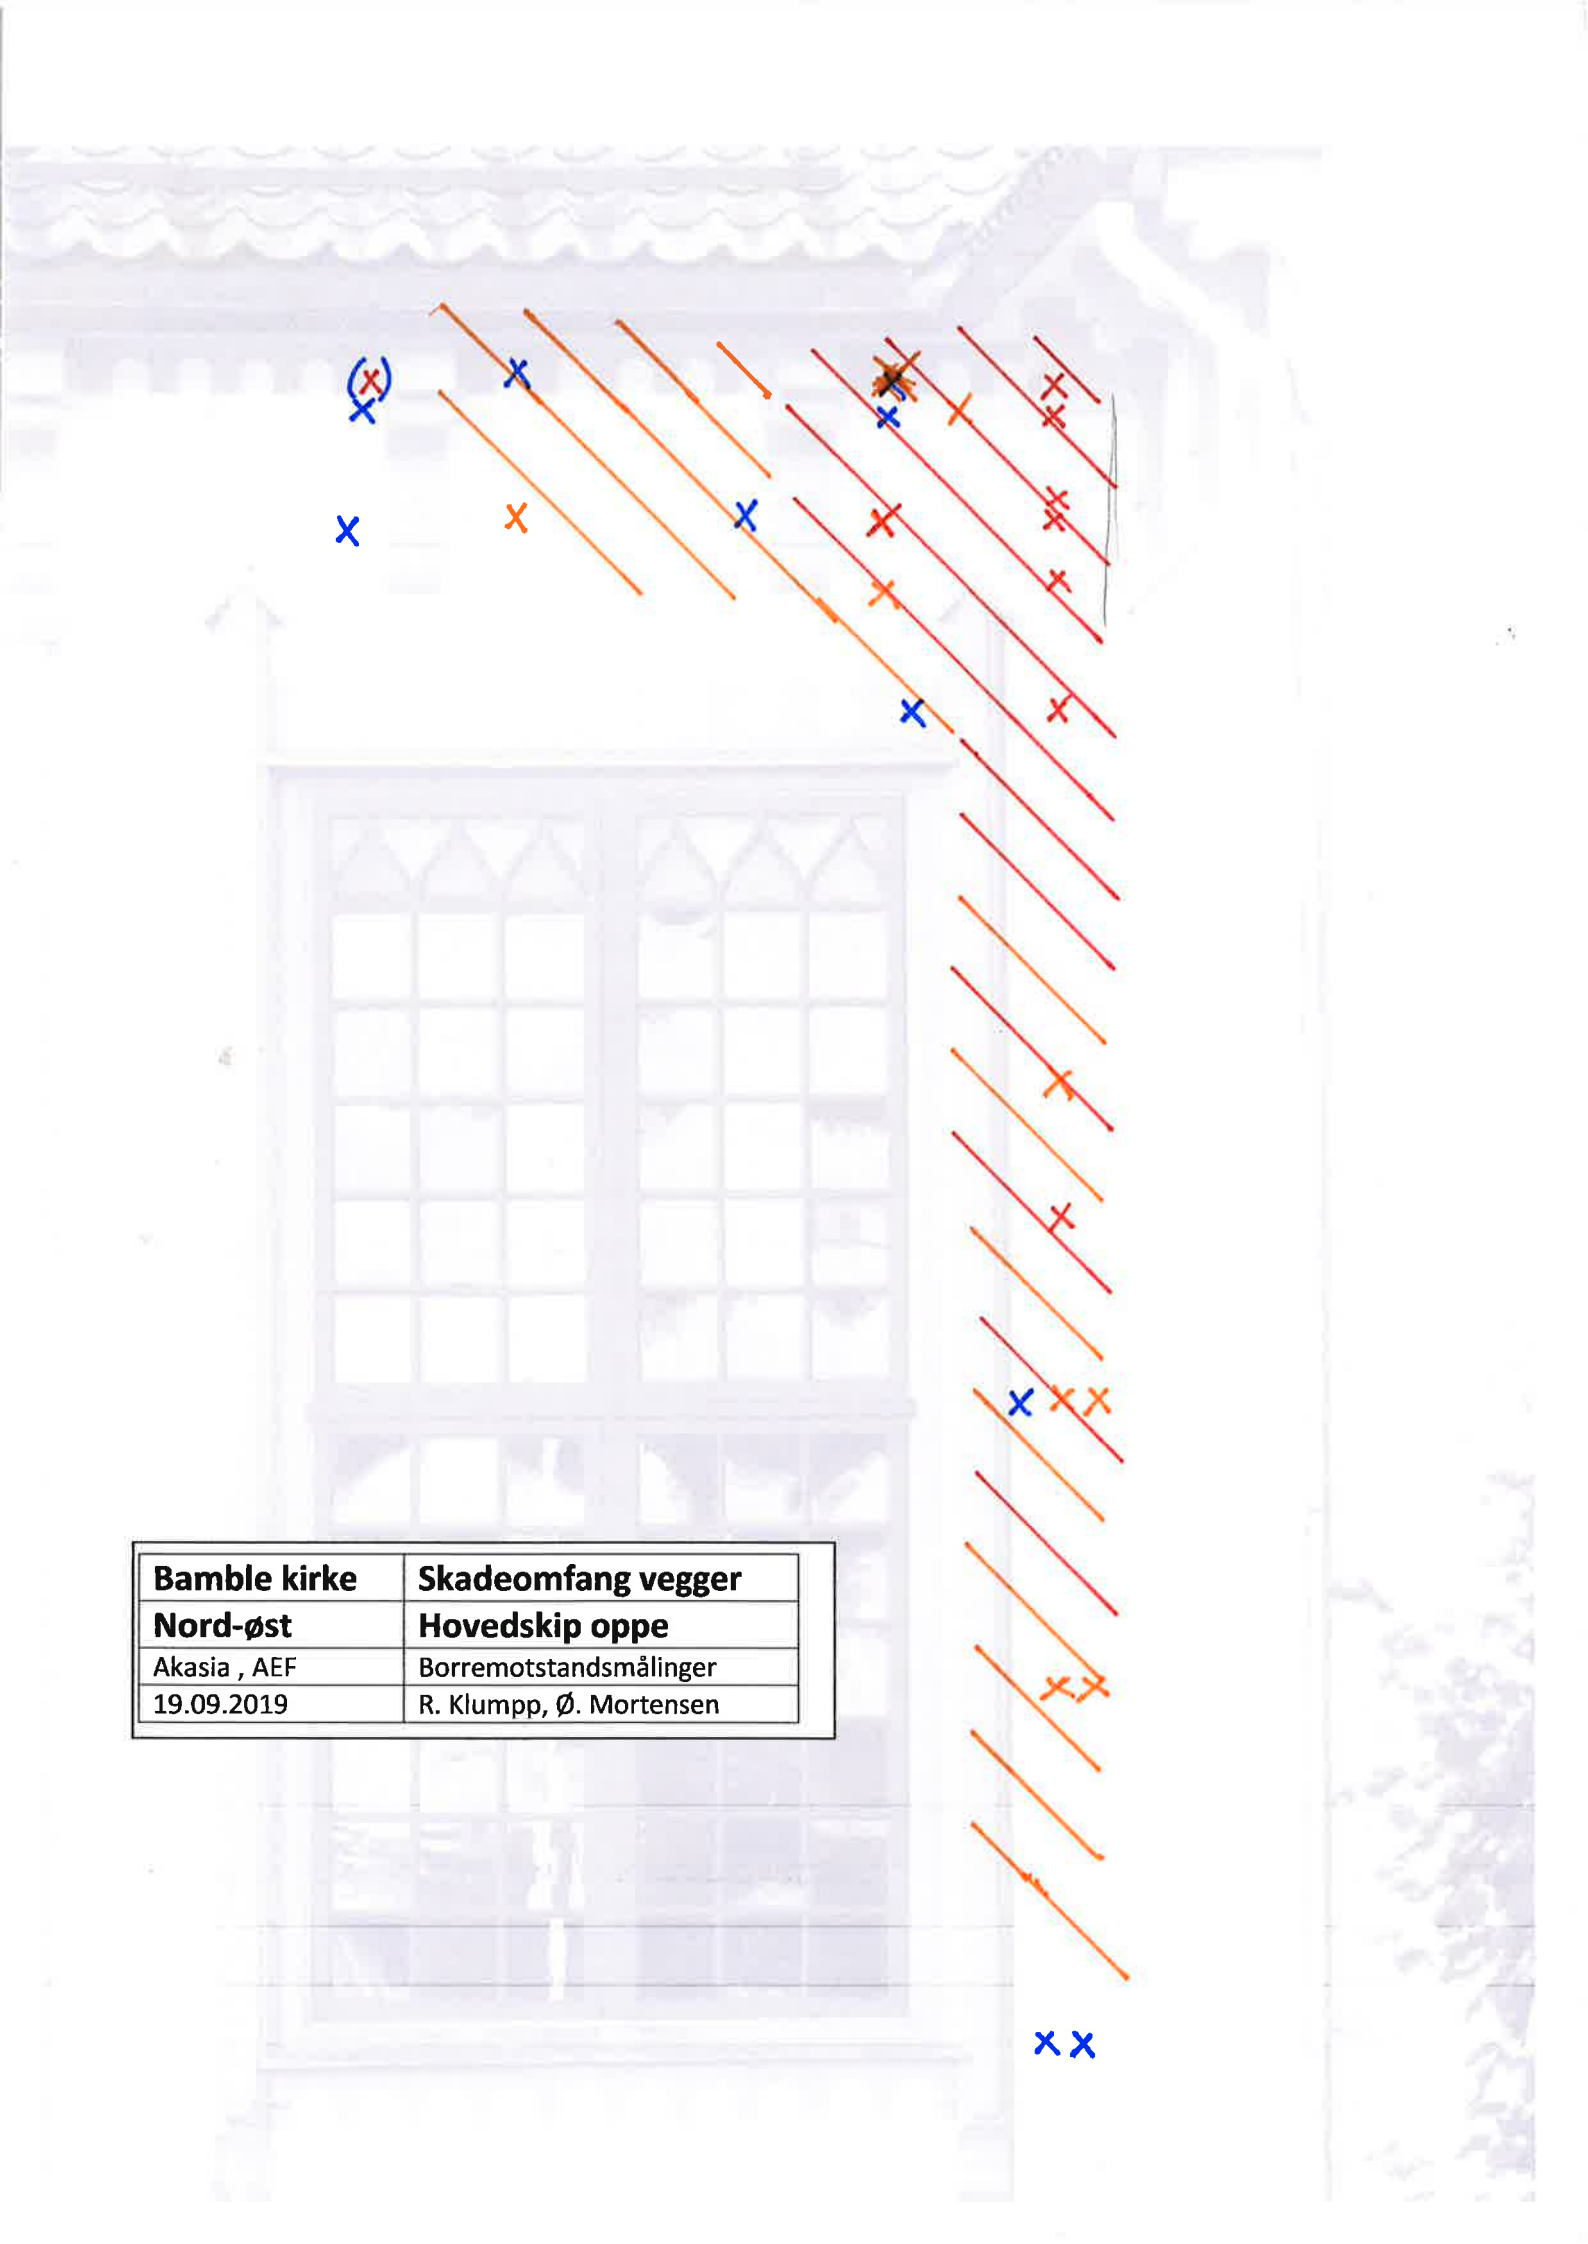
| <b>Nord-øst</b> | <b>Hovedskip oppe</b> |

| <b>Bamble kirke</b> | <b>Skadeomfang vegger</b> |
| Akasia , AEF | Borremotstandsmålinger |

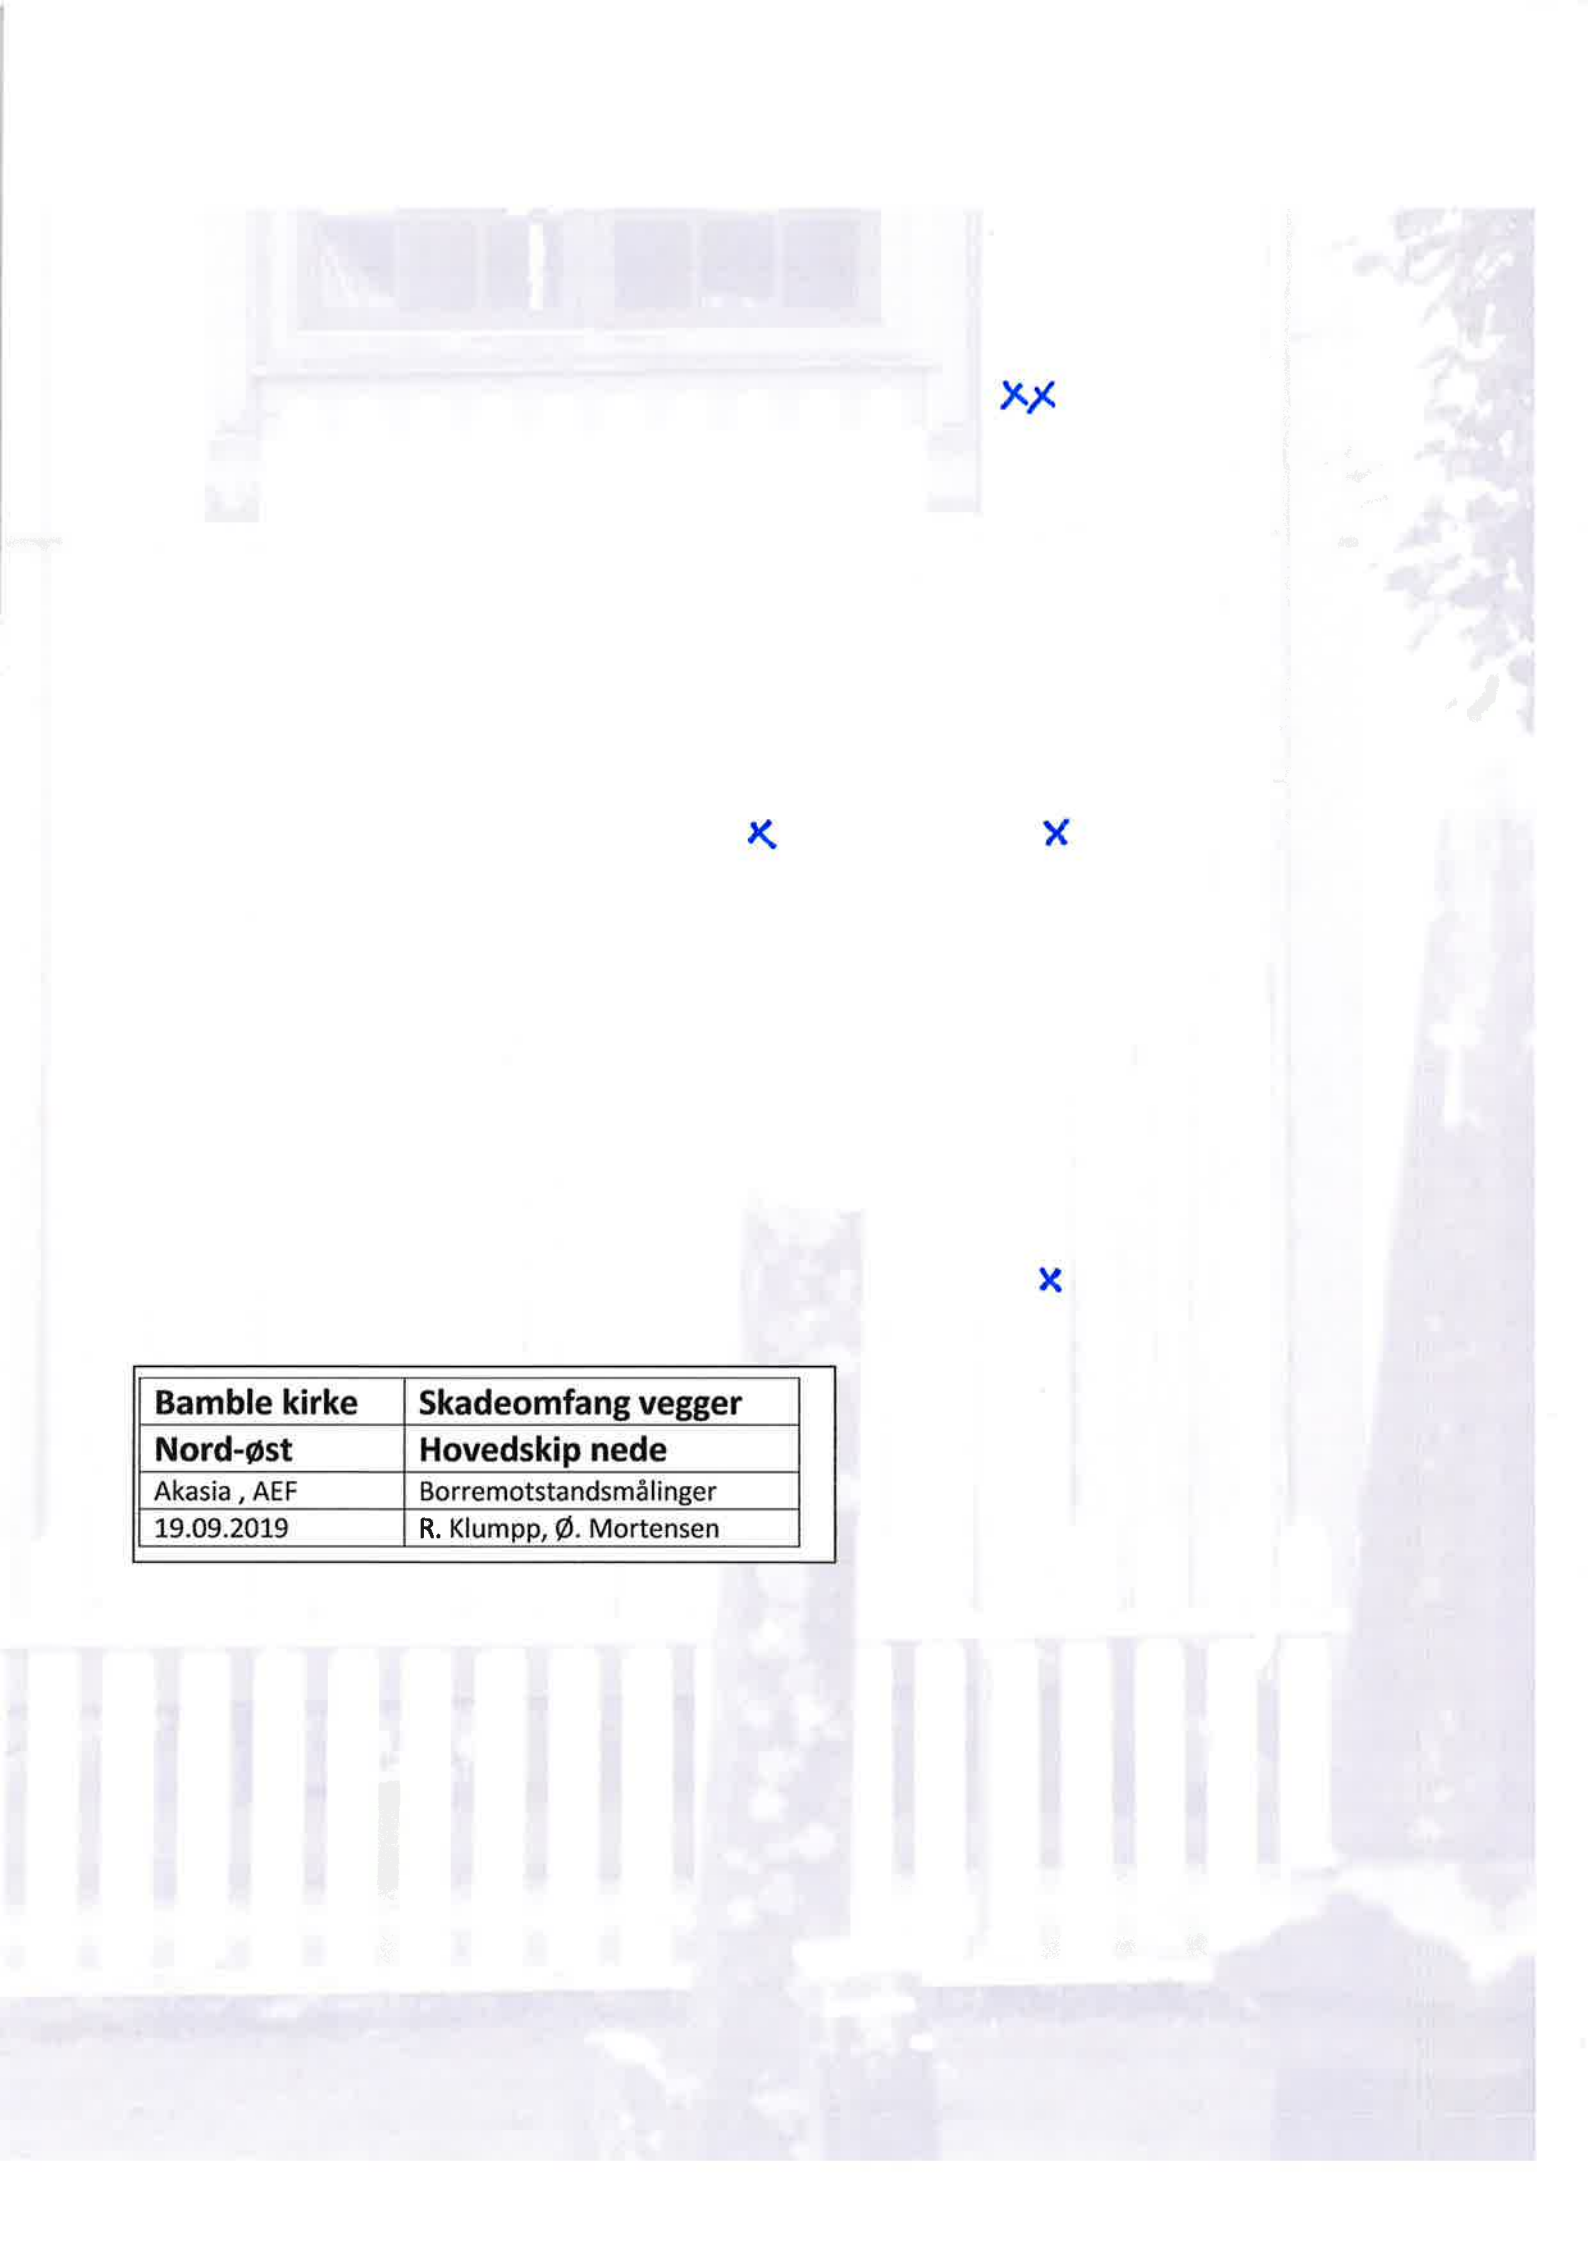
| <b>Nord-øst</b> | <b>Hovedskip nede</b> |

| <b>Bamble kirke</b> | <b>Skadeomfang vegger</b> |
| Akasia , AEF | Borremotstandsmålinger |
